Asbestos Refurbishment Survey

The Old Chapel
Watergate Street
Llanfair Caereinion
Welshpool
Powys
SY21 0RG

24-7 Asbestos Services

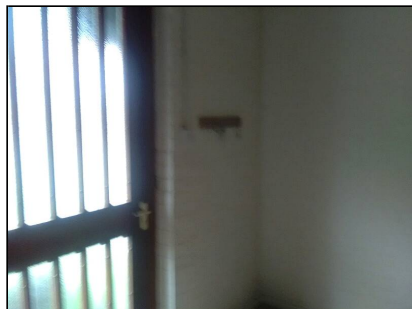
Survey Date:	Lead Surveyor	Survey Type	Floor	Analysis
7 Apr 2021	James Corrigan	Refurbishment Survey	Ground Floor	
Building	Room	Item	Quantity	N/A
The Old Chapel, Watergate Street	Hallway G01	No suspect material found	N/A	
Sample No (S,SP,P,As)	Product Type	Surface Treatment	Condition	Accessibility
Visual (P)	N/A	N/A	N/A	N/A
Material Risk Score				
N/A				
Recommended action	No further action required			
Surveyor comments	N/A

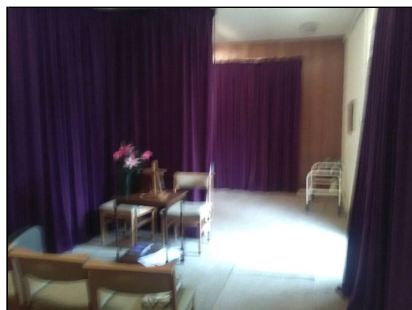
Survey Date:	Lead Surveyor	Survey Type	Floor	Analysis
7 Apr 2021	James Corrigan	Refurbishment Survey	Ground Floor	
Building	Room	Item	Quantity	N/A
The Old Chapel, Watergate Street	Chapel G02	No suspect material found	N/A	
Sample No (S,SP,P,As)	Product Type	Surface Treatment	Condition	Accessibility
Visual (P)	N/A	N/A	N/A	N/A
Material Risk Score				
N/A				
Recommended action	No further action required			
Surveyor comments	N/A

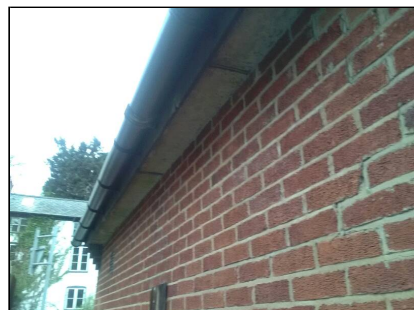
Survey Date:	Lead Surveyor	Survey Type	Floor	Analysis
7 Apr 2021	James Corrigan	Refurbishment Survey	External	
Building	Room	Item	Quantity	N/A
The Old Chapel, Watergate Street	External E01	No suspect material found	N/A	
Sample No (S,SP,P,As)	Product Type	Surface Treatment	Condition	Accessibility
Visual (P)	N/A	N/A	N/A	N/A
Material Risk Score				
N/A				
Recommended action	No further action required			
Surveyor comments	N/A
