Asbestos Refurbishment Survey

Public toilet's

Institute

Bridge Street

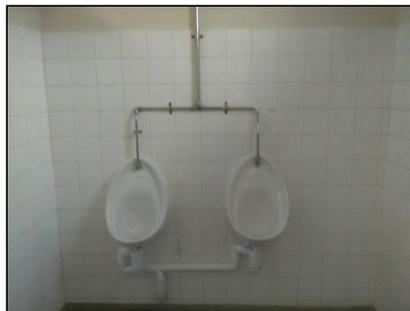
Survey Date:	Lead Surveyor	Survey Type	Floor	Analysis
7 Apr 2021	James Corrigan	Refurbishment Survey	Ground Floor	
Building	Room	Item	Quantity	N/A
Public Toilets, Institute, Bridge Street	Male W.C G01	No suspect material found	N/A	
Sample No (S,SP,P,As)	Product Type	Surface Treatment	Condition	Accessibility
Visual (P)	N/A	N/A	N/A	N/A
Material Risk Score				
N/A				
Recommended action	No further action required			
Surveyor comments	N/A

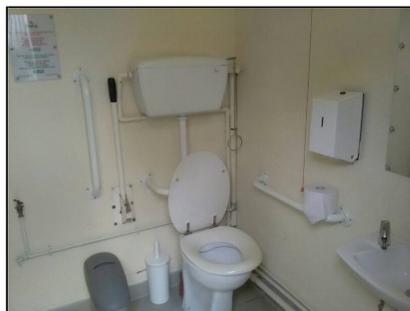
Survey Date:	Lead Surveyor	Survey Type	Floor	Analysis
7 Apr 2021	James Corrigan	Refurbishment Survey	Ground Floor	
Building	Room	Item	Quantity	N/A
Public Toilets, Institute, Bridge Street	Disabled W.C G02	No suspect material found	N/A	
Sample No (S,SP,P,As)	Product Type	Surface Treatment	Condition	Accessibility
Visual (P)	N/A	N/A	N/A	N/A
Material Risk Score				
N/A				
Recommended action	No further action required			
Surveyor comments	N/A

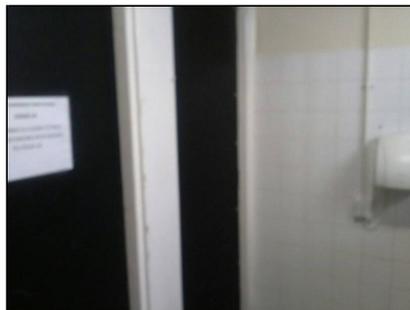
Survey Date:	Lead Surveyor	Survey Type	Floor	Analysis
7 Apr 2021	James Corrigan	Refurbishment Survey	Ground Floor	
Building	Room	Item	Quantity	N/A
Public Toilets, Institute, Bridge Street	Female W.C G03	No suspect material found	N/A	
Sample No (S,SP,P,As)	Product Type	Surface Treatment	Condition	Accessibility
Visual (P)	N/A	N/A	N/A	N/A
Material Risk Score				
N/A				
Recommended action	No further action required			
Surveyor comments	N/A

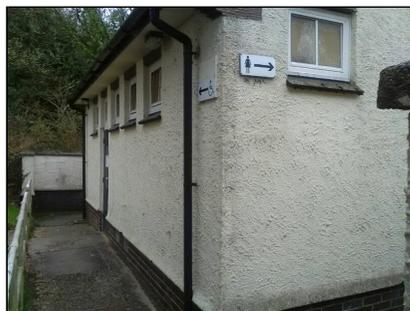
Survey Date:	Lead Surveyor	Survey Type	Floor	Analysis
7 Apr 2021	James Corrigan	Refurbishment Survey	External	
Building	Room	Item	Quantity	N/A
Public Toilets, Institute, Bridge Street	External E01	No suspect material found	N/A	
Sample No (S,SP,P,As)	Product Type	Surface Treatment	Condition	Accessibility
Visual (P)	N/A	N/A	N/A	N/A
Material Risk Score				
N/A				
Recommended action	No further action required			
Surveyor comments	N/A
