Ancient Woodland Restoration

Deri Wood / Coed y Deri

Woodland Name: Deri Wood / Coed y Deri Location: Llanfair Caereinion, Powys Grid ref: SJ097066 Total Woodland Area: 5.35ha Area PAWS: 4.14ha (On Inventory as RAWS) Area ASNW: None (Riverside section of Goat Field could be considered ASNW) Area RAWS: None Area AWI Unknown: None Designations: None Ownership: Llanfair Caereinion Town Council Managed By: Montgomeryshire Wildlife Trust & Llanfair Caereinion Town Council Field Survey: 16th May 2016, 17th June 2016, 18th August 2016 & 10th October 2016 Report Date: 20th October 2016 Report Author: Alastair Hotchkiss (Ancient Woodland Restoration Officer, Woodland Trust)

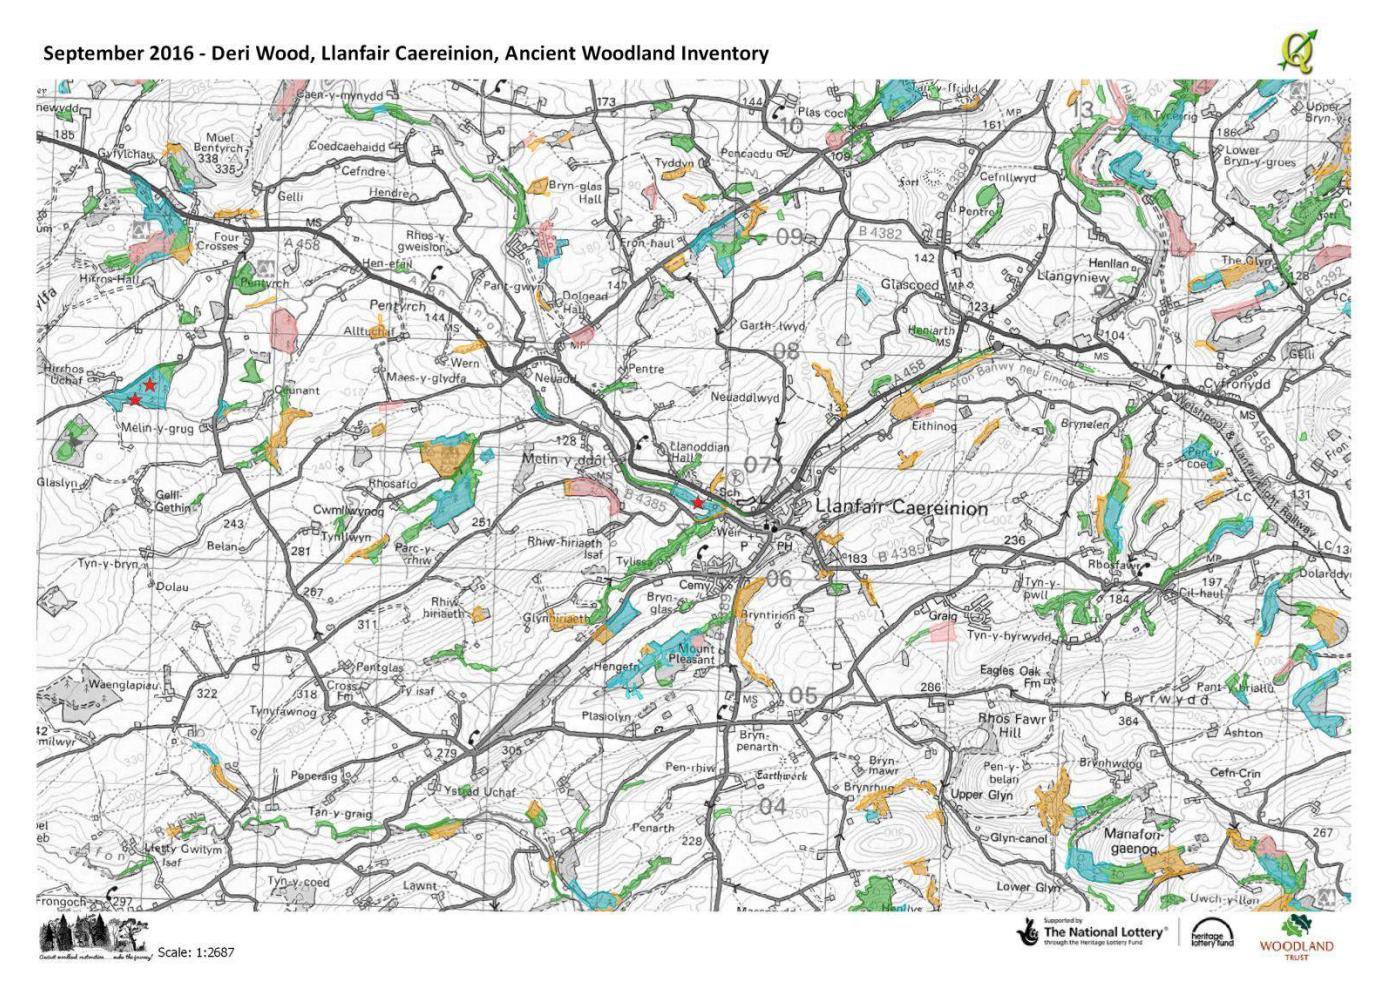
Figure 1 - Ancient Woodland Inventory for Wales (2011) in the area around Deri Wood (shown by red star in centre). Blue is PAWS, Orange is RAWS, Green is ASNW and Pink is AW of unknown category. This shows the fragmented patchwork of ancient woodland.

The Ancient Woodland Inventory for Wales (see figure 1 and 2), most recently updated in 2011, attempts to identify woodlands that have been more or less continuously wooded since the 1600's. This should still be seen as provisional, and field survey or desk-based evidence can be used to more accurately assign the woodland status, if the status or boundary on the inventory is considered incorrect. In Wales, the inventory is managed by Natural Resources Wales (NRW). The relevant definitions are:

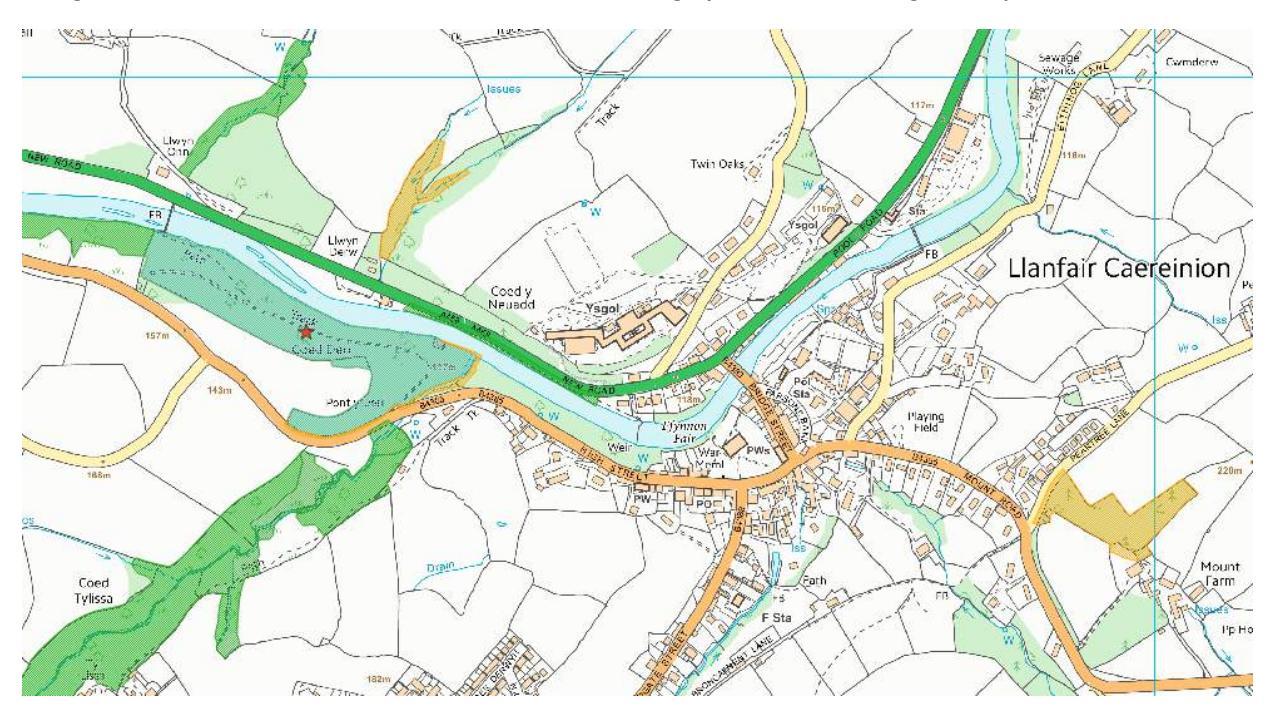
Figure 2 - Ancient Woodland Inventory - Deri Wood - Showing amended category. The light blue PAWS area is on the inventory as orange (RAWS). The slither of RAWS showing at the eastern edge of the site alongside the stream is more appropriate.

The main part of Deri Wood is mapped on the most recent Ancient Woodland Inventory for Wales (2011) as Restored Ancient Woodland Site (RAWS). This is considered incorrect, and the site is best regarded as almost entirely plantation on ancient woodland (PAWS). This is not clear from the aerial photographs, and it is rather unusual in that many of the conifer and beech stands have been underplanted beneath large old oaks which still dominate the canopy in places. The dominance of beech is also another factor why this has been incorrectly mapped as RAWS, simply because the aerial photography could not distinguish beech from other native broadleaved trees. None of Goat Field is mapped as ancient woodland on the Inventory. This has not been particularly investigated further, and it is understood that this part of the site was more open (as the name suggests), and it does appear to have been planted more recently. However, the strip nearest the river is rich with ancient woodland indicator plants, and older coppiced trees like alder, ash, hazel, yew and oak, and it is felt that this riverside strip has probably had woodland cover for a long time, and is perhaps best considered as ancient semi-natural woodland (ASNW), as the dingle woodland on the edge of the stream which joins the Banwy near the old pump house.

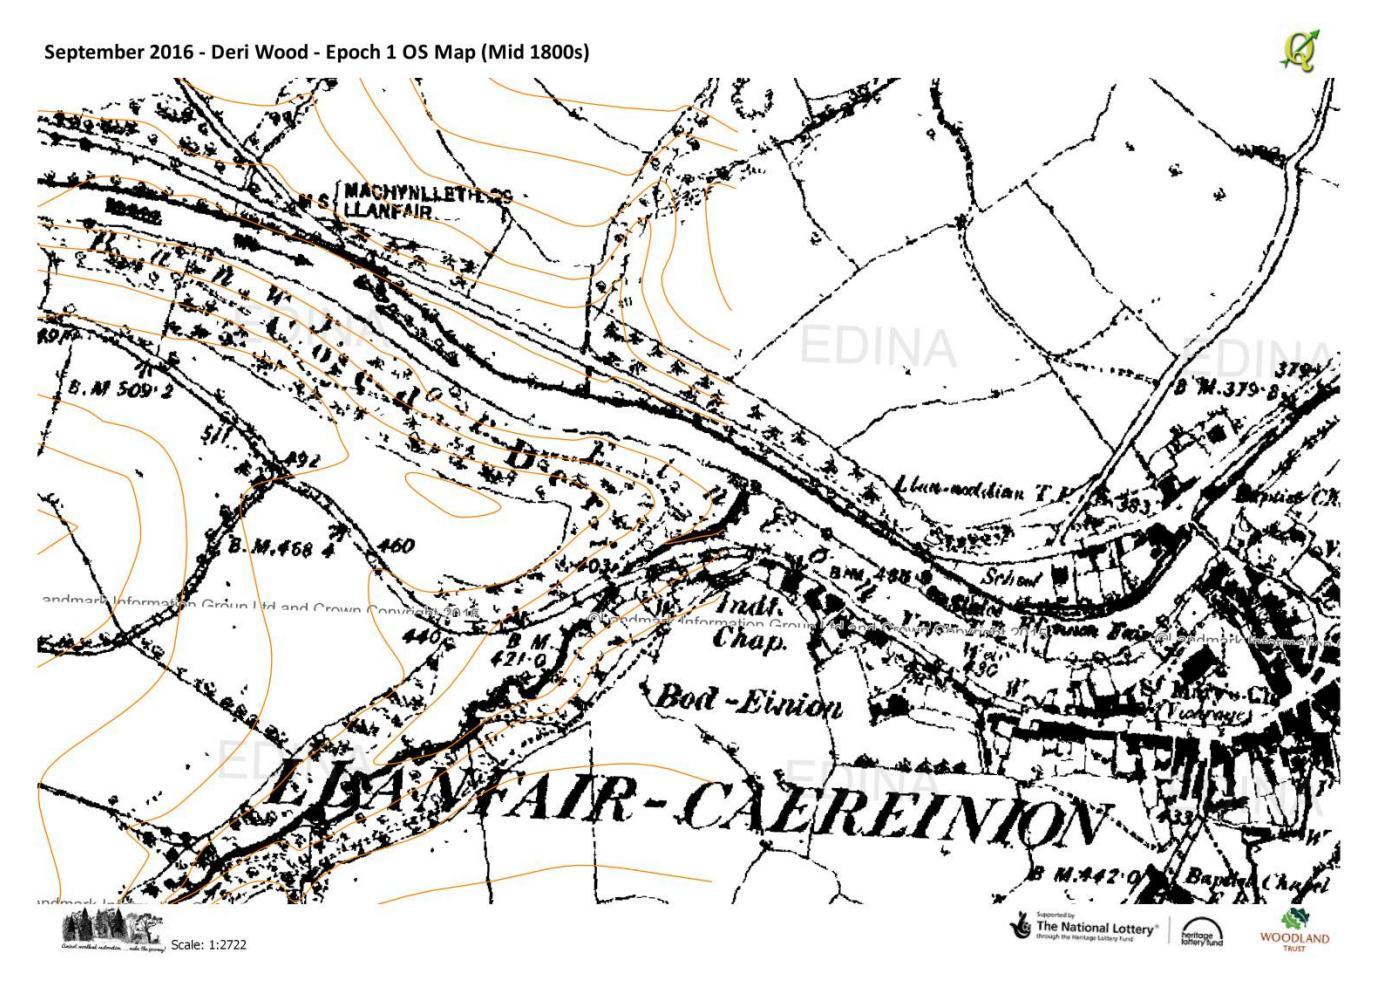
Figure 3 - Epoch 1 OS Map (Mid 1800's) showing Deri Wood as mainly a broadleaved woodland, but with a few conifer symbols too.

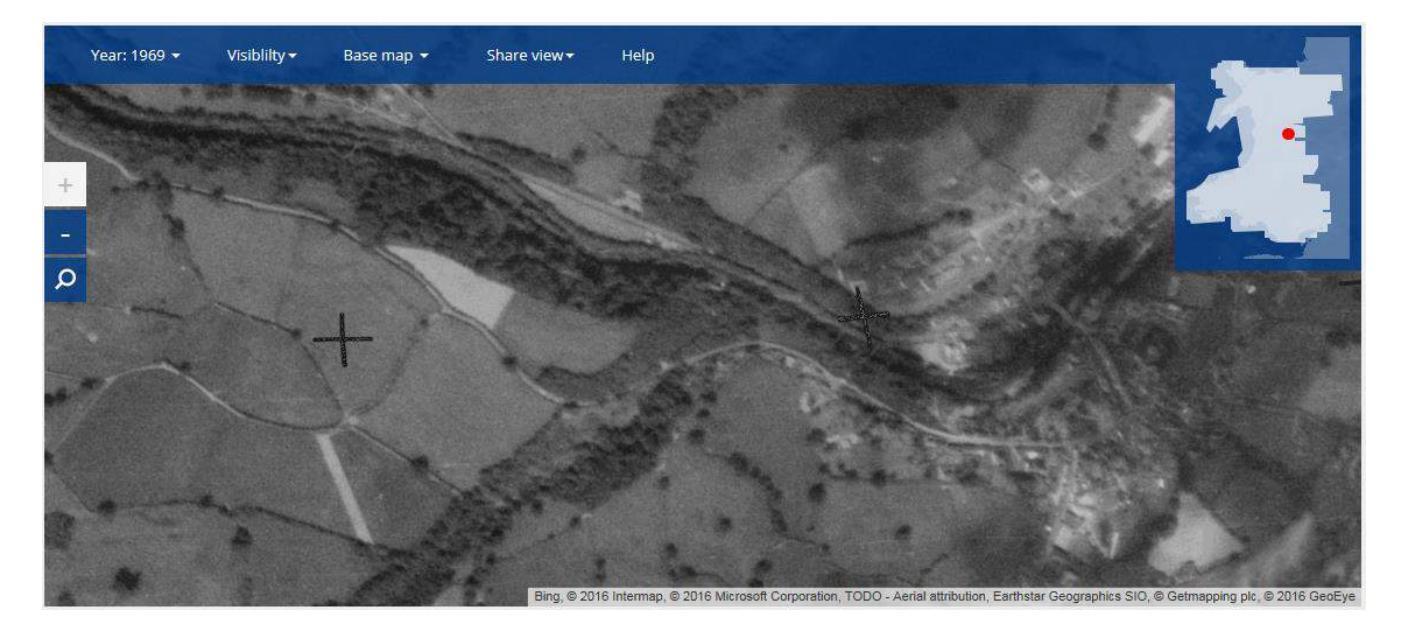
Figure 4 - 1969 aerial photograph of Deri Wood, showing a clear distinction between the westernmost part of the site and the southern part nearest the road which appears to be perhaps a younger stand of trees.

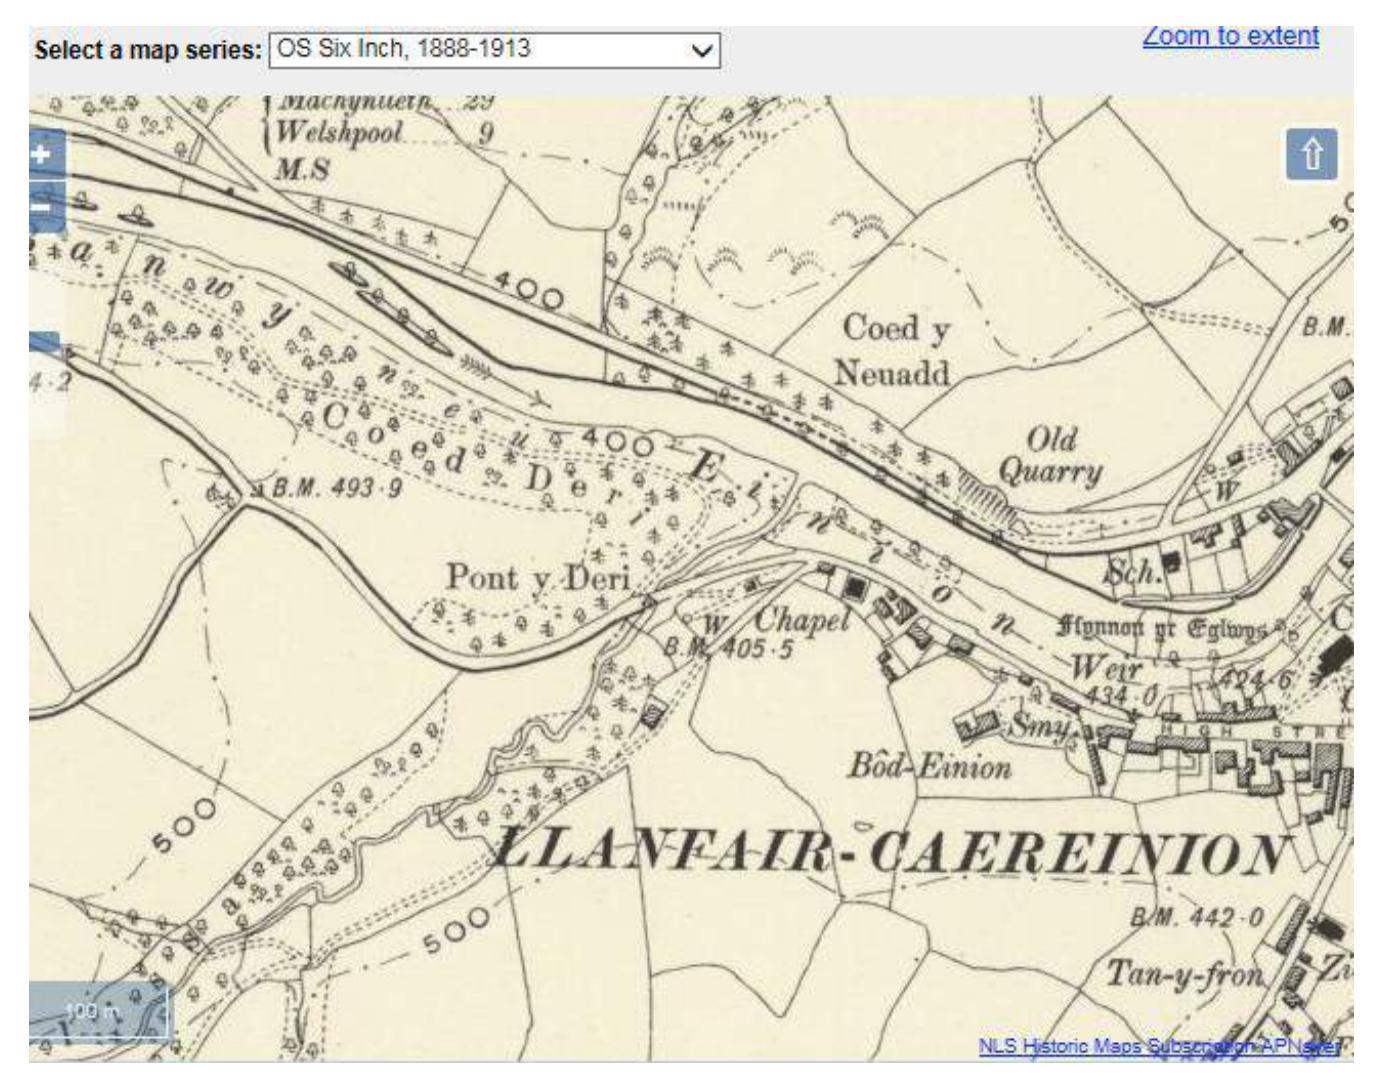
Figure 5 - OS Six Inch Map (1888-1913) clearly showing the main part of Deri Wood as a broadleaved woodland, but with the density of conifer symbols in the southern part of the site near the road. The fringe of riverside woodland in Goat Field is also shown.

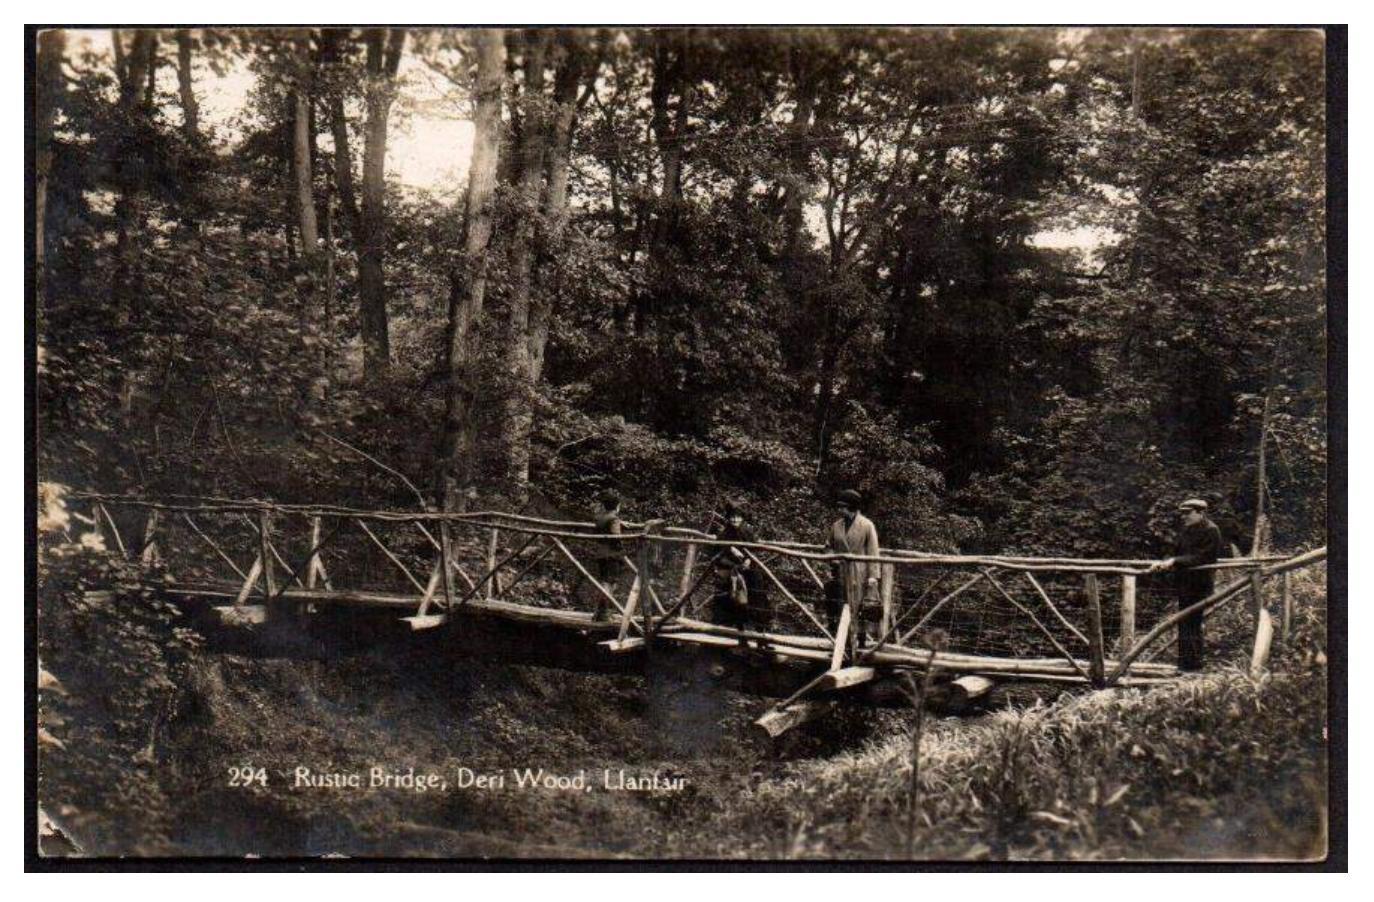
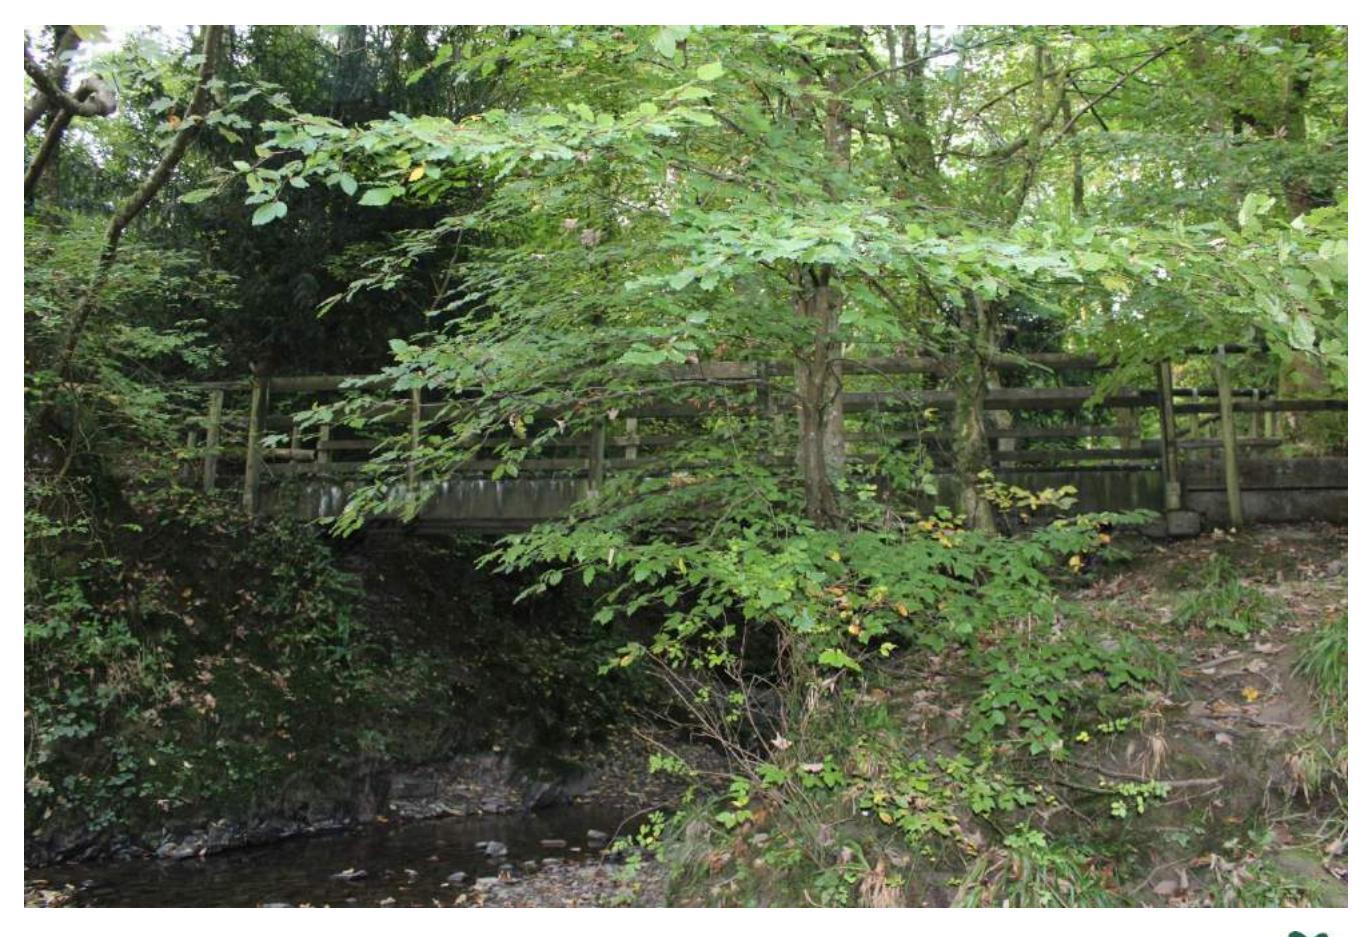
Figure 6 - Deri Wood - An old image (unknown date) of a postcard found on the internet. Presumably this is the bridge of the main stream where it joins the Banwy, between Deri Wood and Goat Field – The current bridge shown below (Oct 2016).

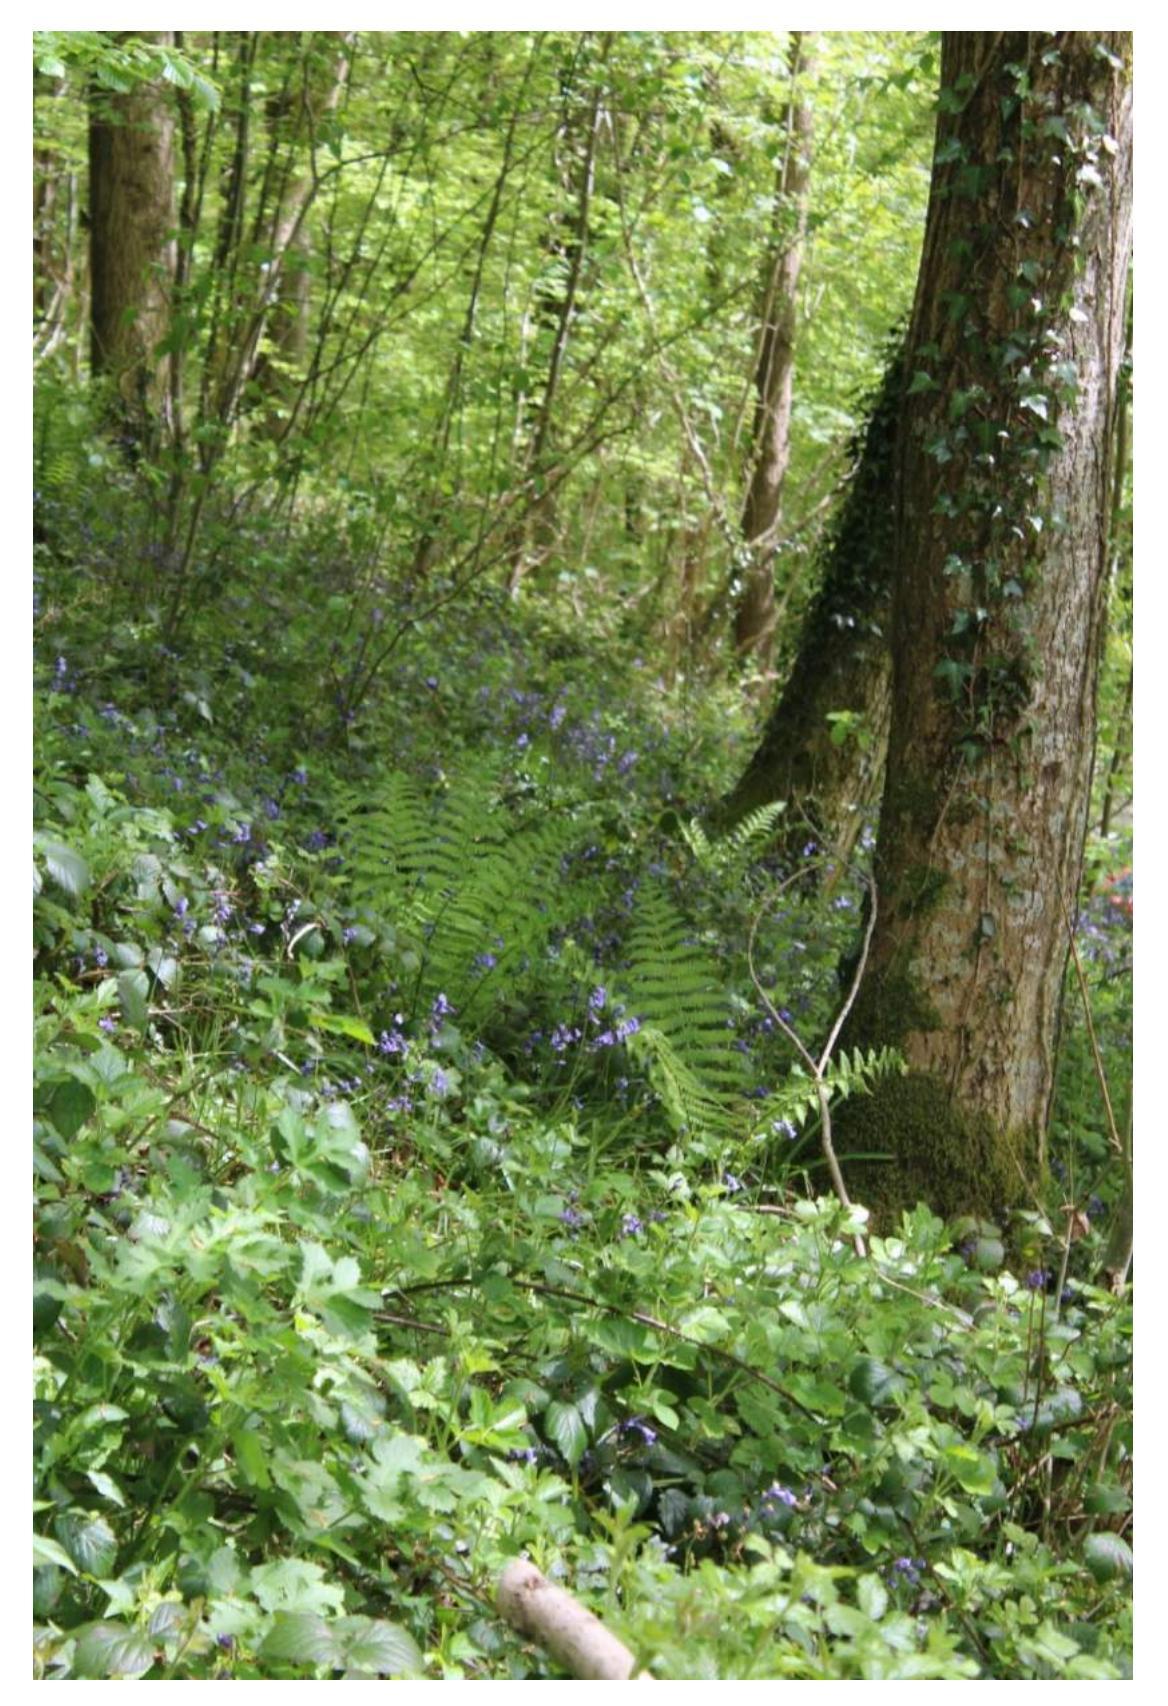
Figure 7 - <u>Cmpt 1a</u> - Secure, with many characteristics of ASNW. Abunant ground flora with bluebell (F), Dogs mercury (F), Bramble (A), Scaly male fern (F). Canopy with abundant oak, and understory with hazel. Good ground cover for ground nesting birds and generally less disturbance than the rest of the wood (May 2016)

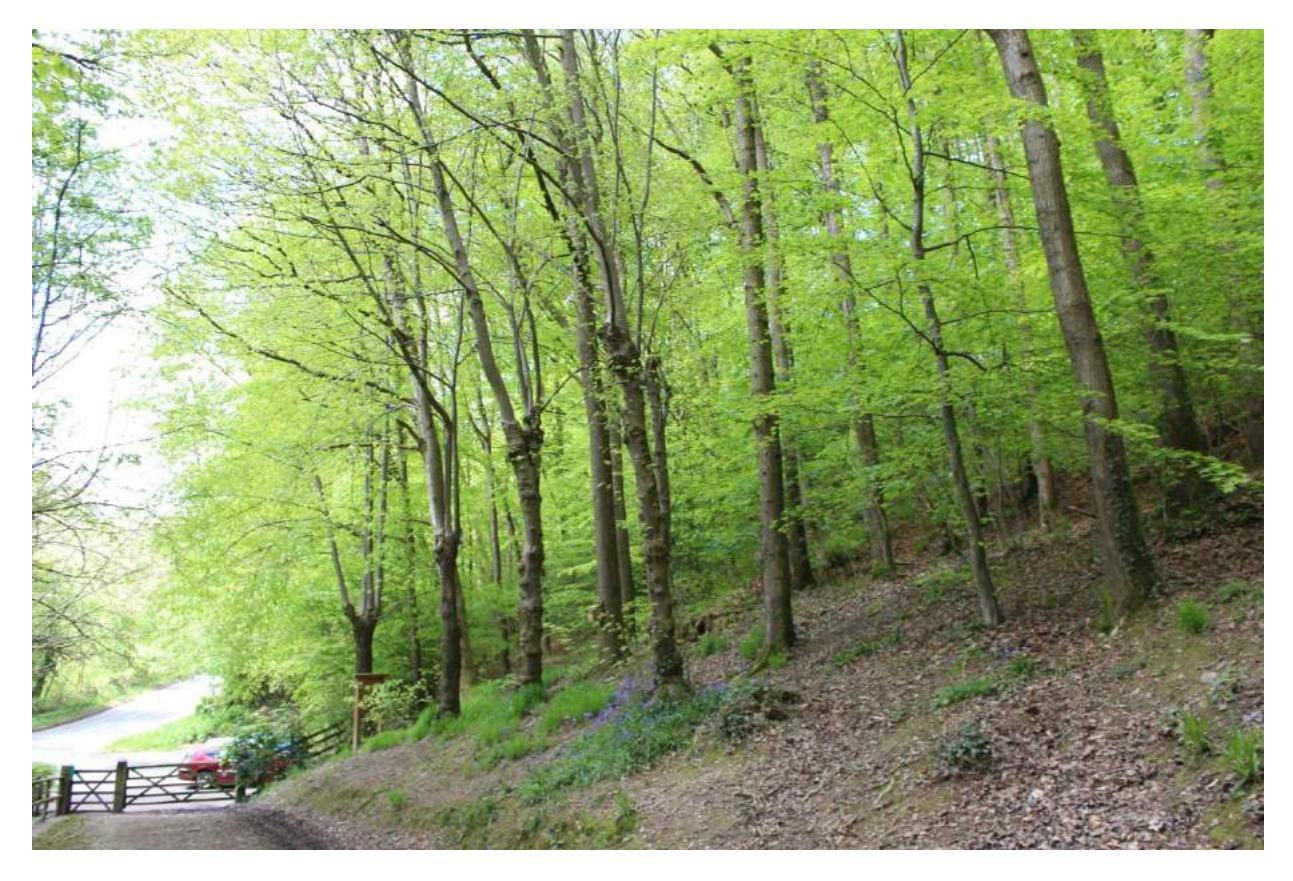
Figure 8 - <u>Cmpt 1b</u> - Western end of compartment near car park. Canopy oak and beech and abundant beech understory with pollarded large-leaved limes on trackside. Showing pockets of bluebells and ground vegetation on track edge where light is getting in, and the bare ground and heavy leaf litter in the denser beech understory areas. (May 2016)

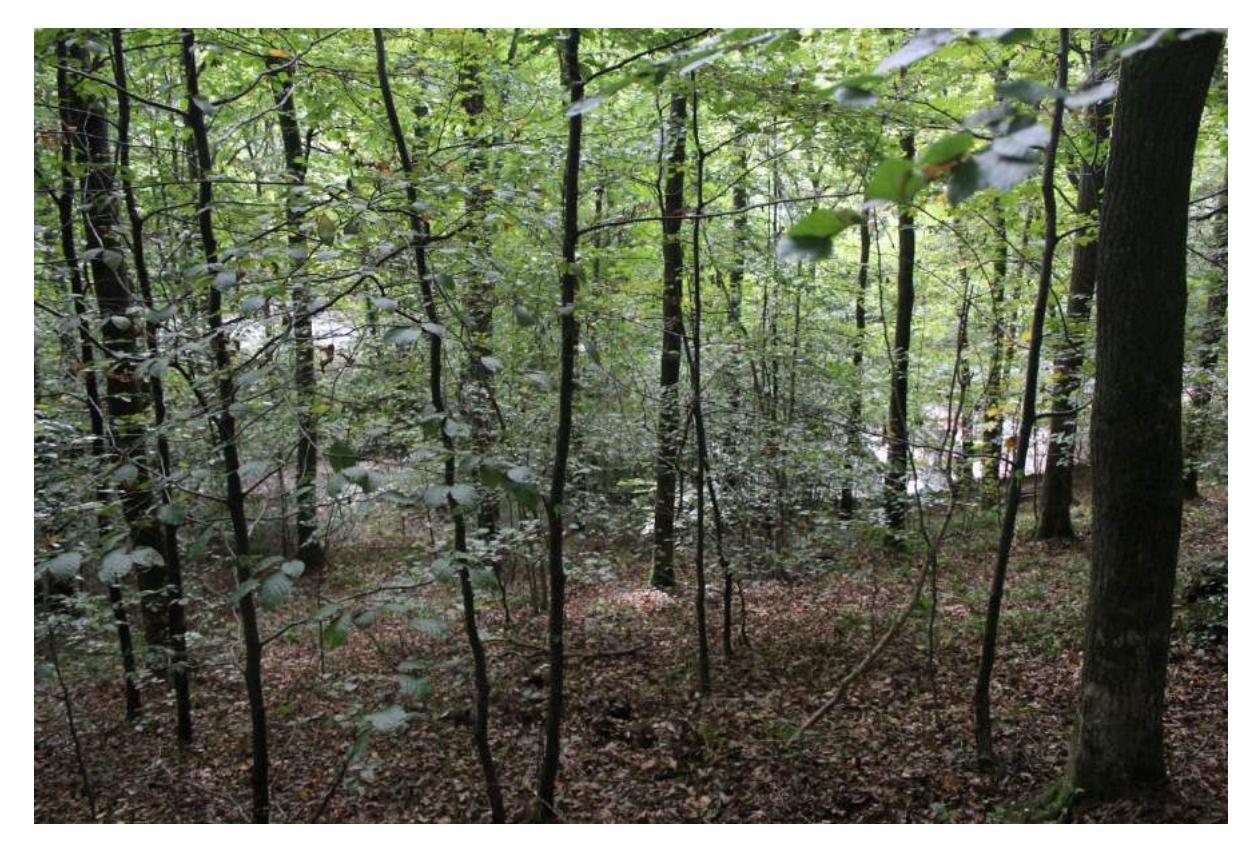
Figure 9 - <u>Cmpt 1b</u> - Oak and beech canopy and dominant beech understory in the middle of Cmpt 1b. (October 2016)

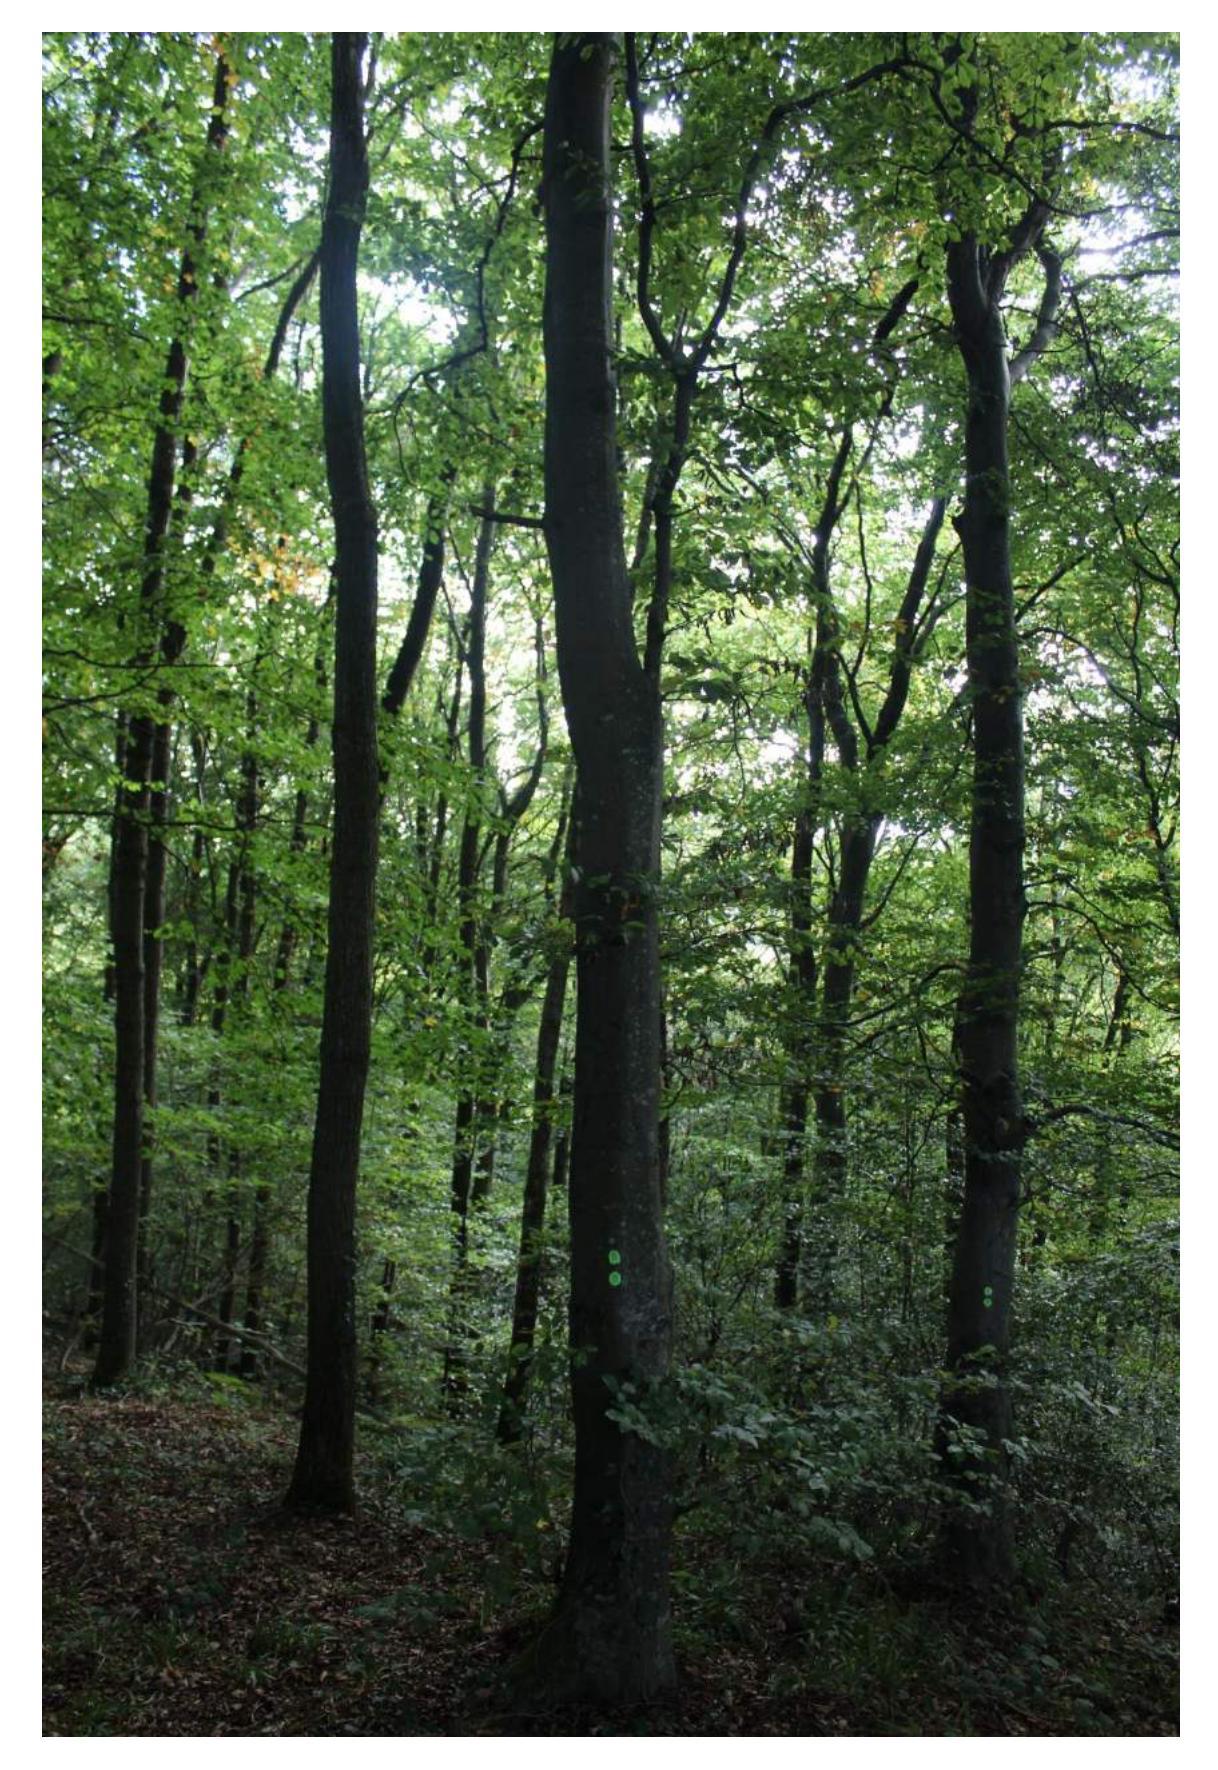
Figure 10 - <u>Cmpt 1b</u> - Mature beech and oak in canopy - showing two marked beech on right as example of what could be thinned to let light in and give space to develop oak (two trees to the left for example) (October 2016)

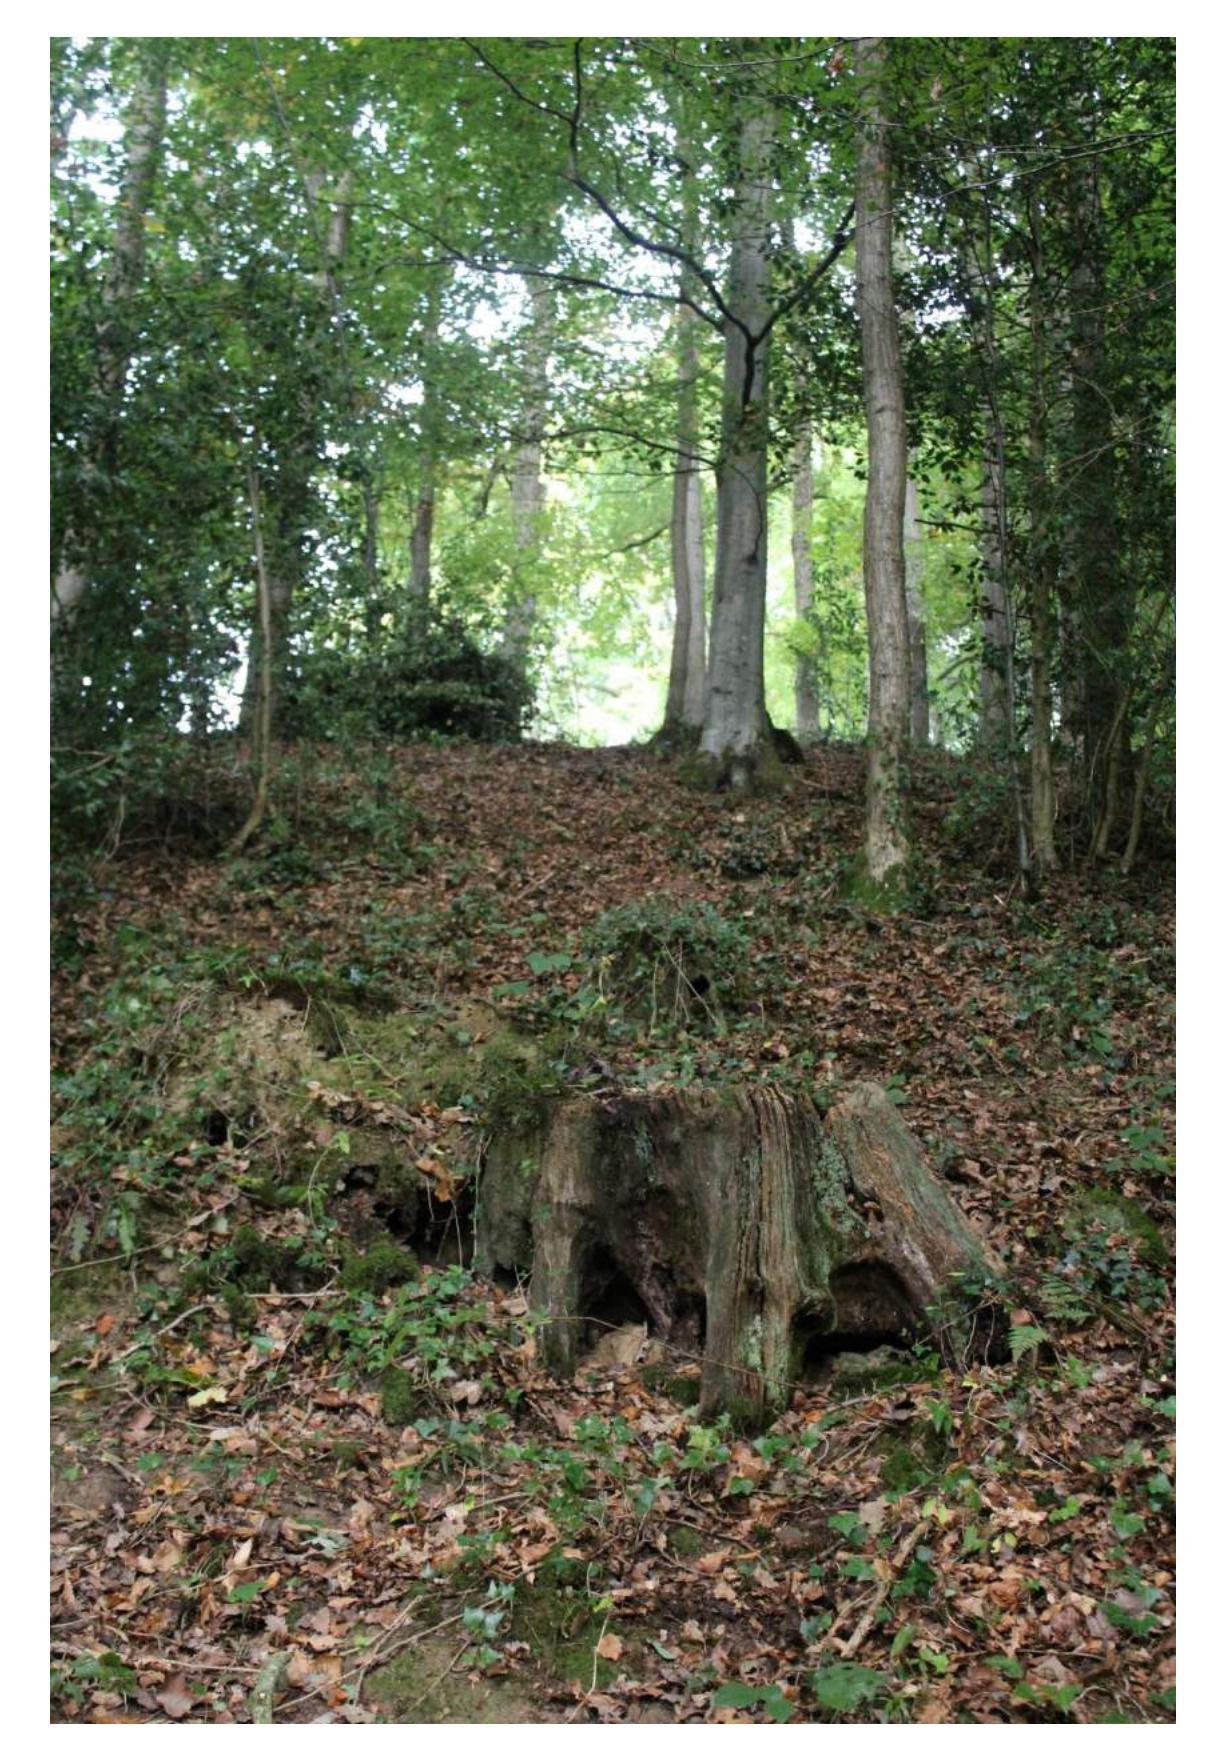
Figure 11 - <u>Cmpt 1b</u> - Pre-plantation deadwood - an old oak stump. These features are typical throughout this compartment and the site, and many of the remaining large oaks on the site give an indication of what some of these old trees would have been like (October 2016)

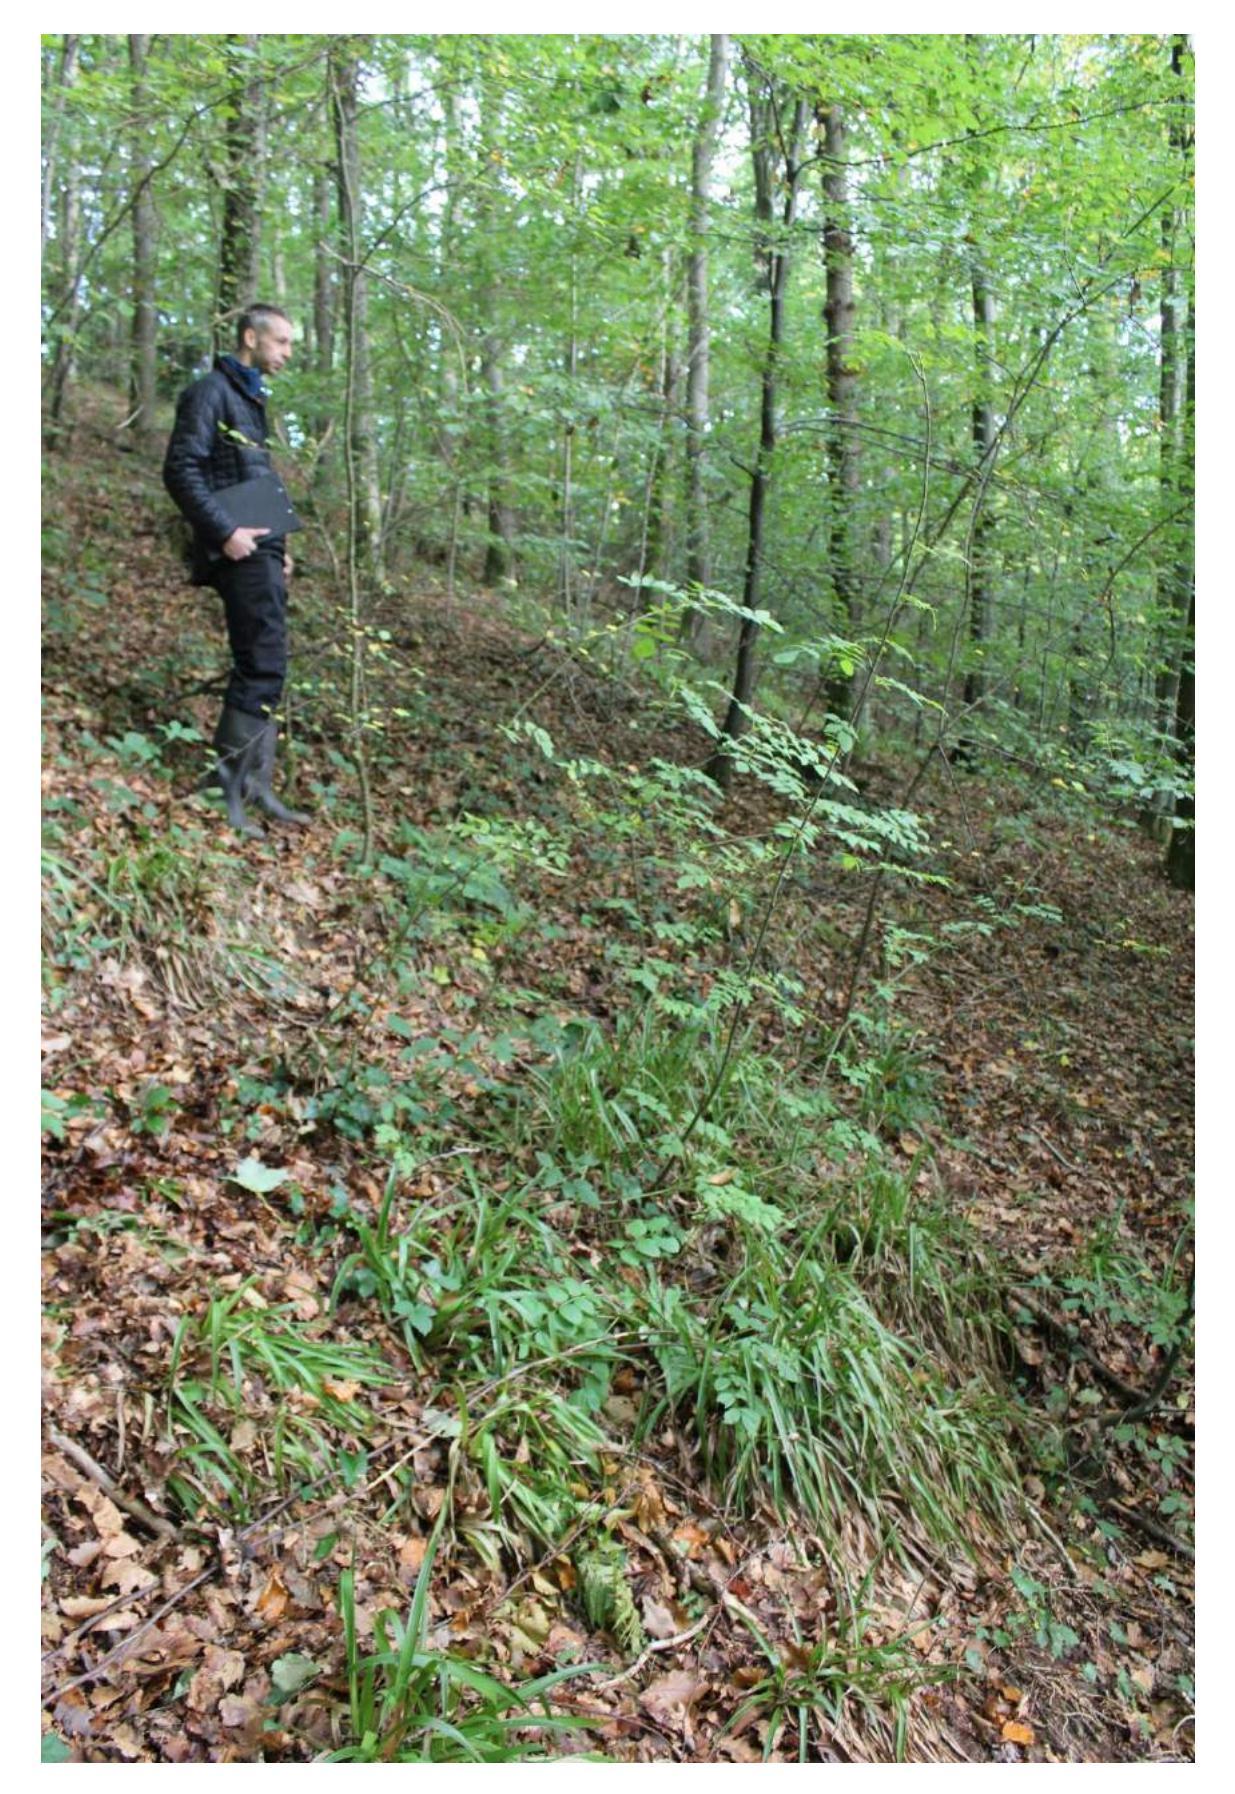
Figure 12 <u>- Cmpt 1b</u> - Example of the hotspot pockets of native tree regeneration (ash in this case) and ground vegetation (great wood-rush) where some light is getting to the ground. An example of what could be 'released' and enhanced through thinning the beech.

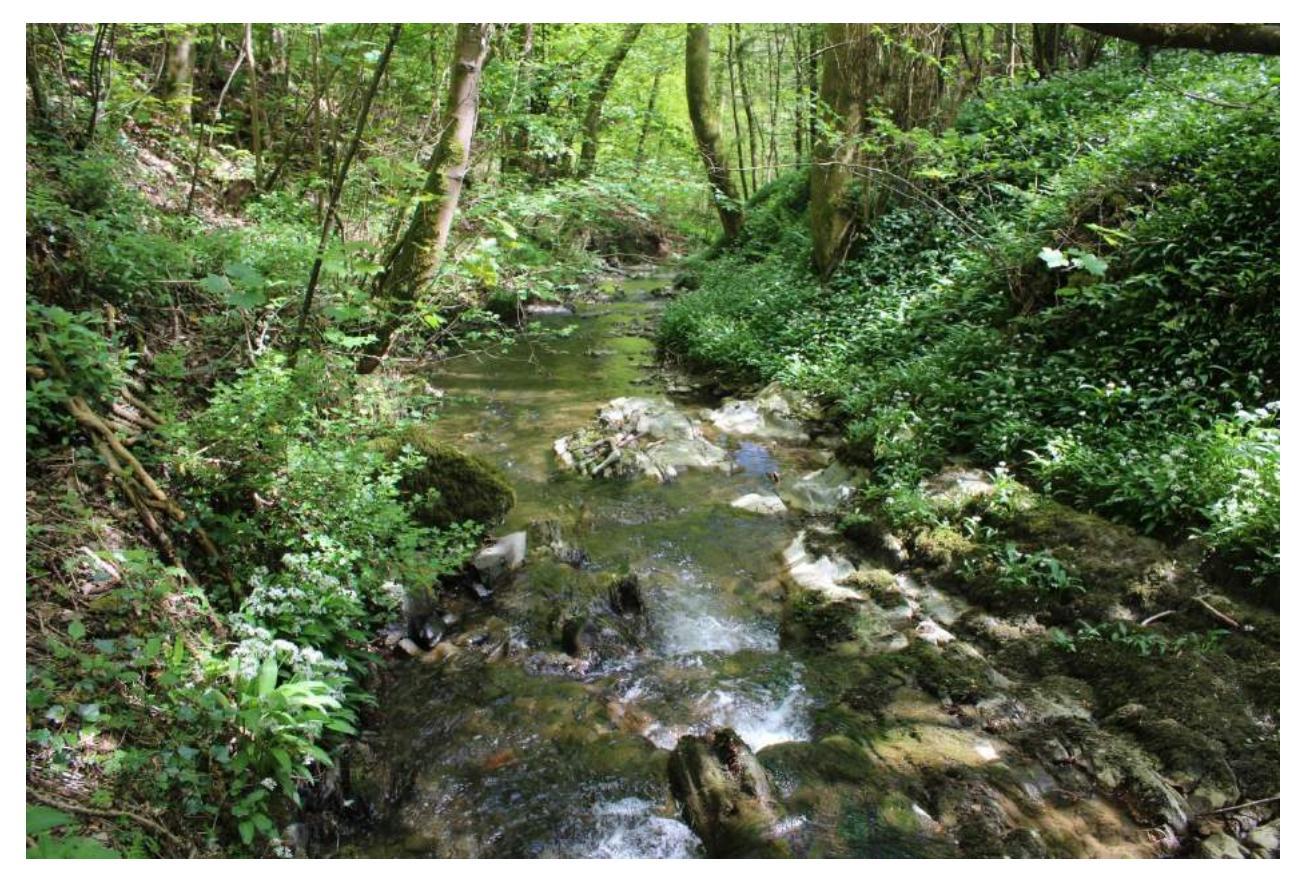
Figure 13 - Figure 15 - <u>Cmpt 1c</u> - the rich streamside woodland fringed with wild-garlic and with species indicative of more base-rich soils such as wych elm and woodruff. (May 2016)

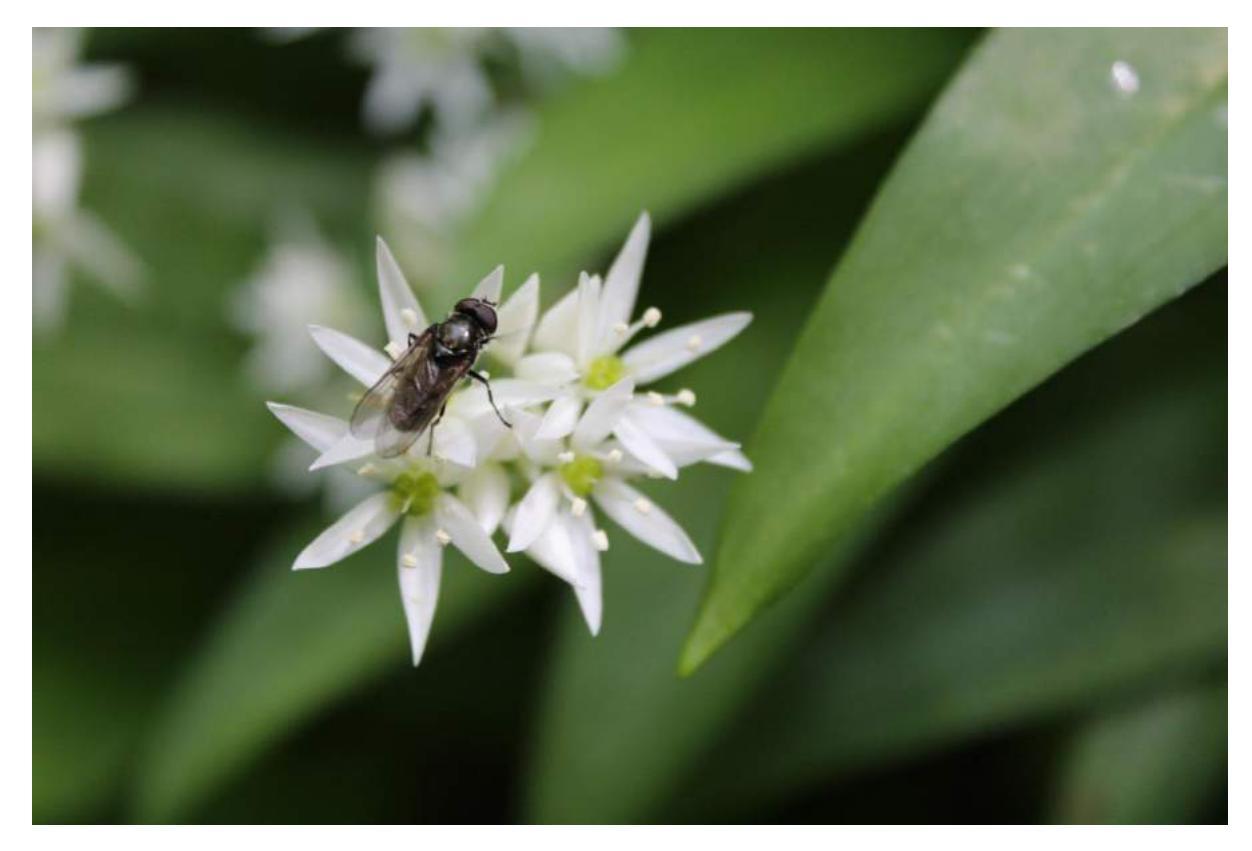
Figure 14 - <u>Cmpt 1c</u> - The wild-garlic hoverfly (Portevinia maculata) which feeds on wild-garlic both as an adult and only on the bulbs of this plant as a larvae. Generally only found in ancient woodland sites (May 2016)
