Ancient Woodland Restoration

Deri Wood / Coed y Deri

Woodland Name: Deri Wood / Coed y Deri Location: Llanfair Caereinion, Powys Grid ref: SJ097066 Total Woodland Area: 5.35ha Area PAWS: 4.14ha (On Inventory as RAWS) Area ASNW: None (Riverside section of Goat Field could be considered ASNW) Area RAWS: None Area AWI Unknown: None Designations: None Ownership: Llanfair Caereinion Town Council Managed By: Montgomeryshire Wildlife Trust & Llanfair Caereinion Town Council Field Survey: 16th May 2016, 17th June 2016, 18th August 2016 & 10th October 2016 Report Date: 20th October 2016 Report Author: Alastair Hotchkiss (Ancient Woodland Restoration Officer, Woodland Trust)

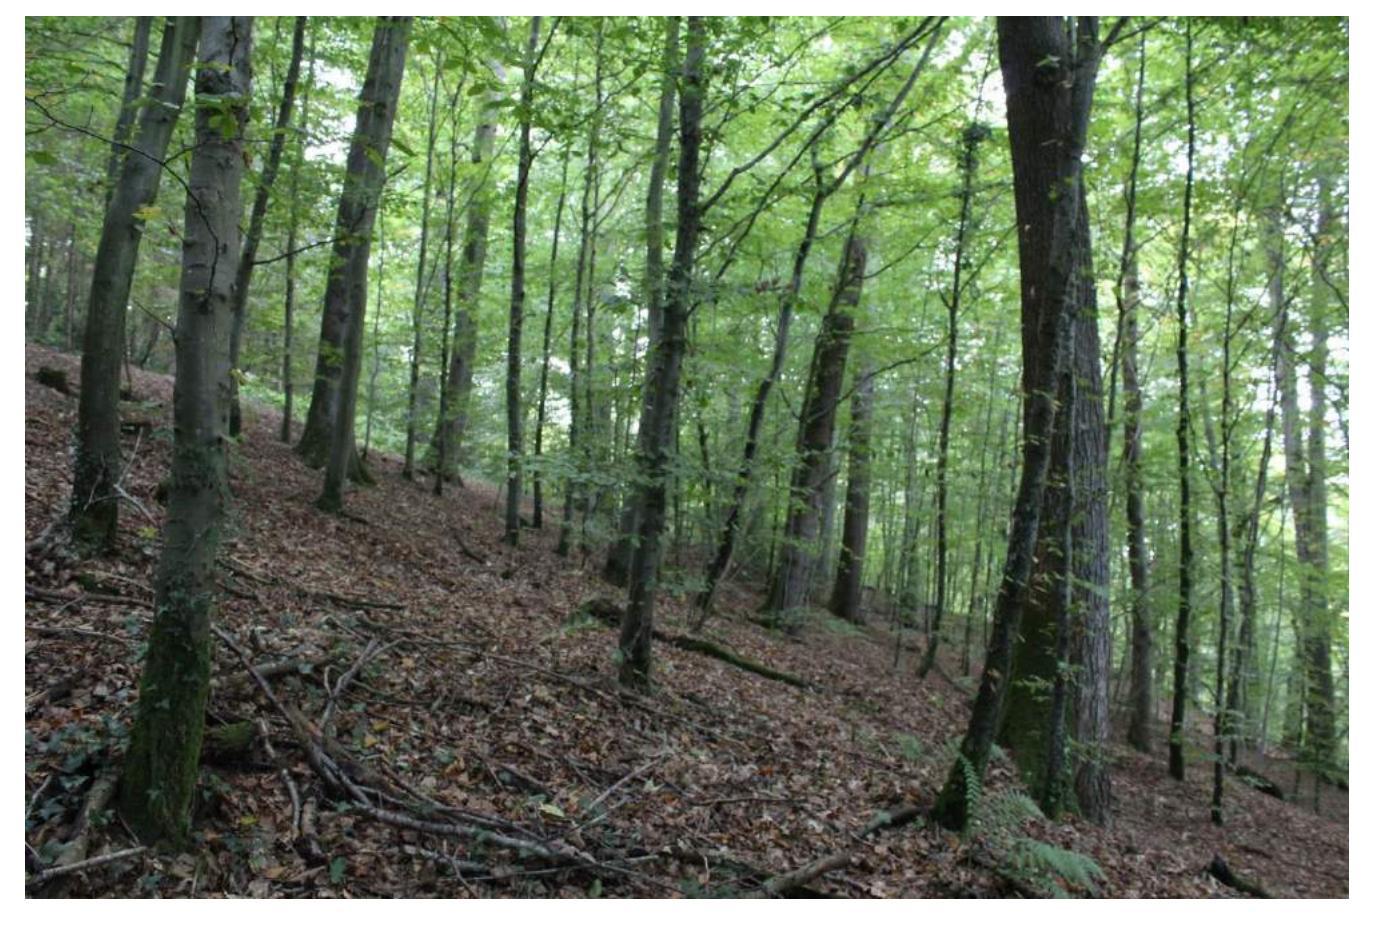
Figure 15 - <u>Cmpt 2a</u> - Mature canopy oak and beech with dense dominant and heavily shading beech understory with sparse ground vegetation.

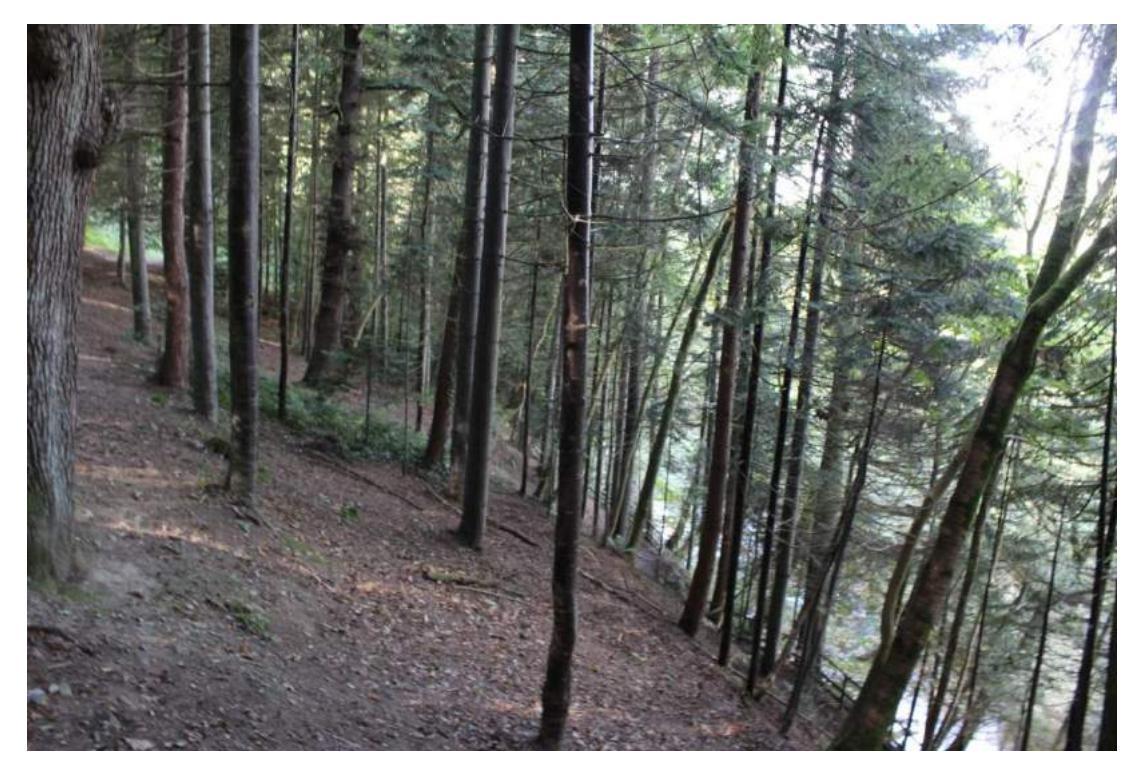
Figure 16 - <u>Cmpt 2b</u> - Dense Grand Fir amongst large mature oaks. Sparse ground vegetation but pockets of ground vegetation and natural tree regeneration can be seen in places (e.g. in this photo left of centre). These pockets could be enhanced through thinning the Grand Fir (October 2016).

(A) with pockets which are probably in a more critical condition (e.g. fig. 16). Beech is also frequent throughout the compartment, and scattered large mature oaks also occur in the canopy (including 9 significant oaks which are mapped on the features map below). In places, additional species such as cherry and ash occur. 3 particularly notable ash are mapped on the features map below (up to 73cm DBH) and are being overtopped and suppressed by adjacent conifers. The main track above makes vehicular access and extraction/winching more straightforward, but it is steep in places and direction of felling (upslope) is crucial given the steep slopes to the river, and the footpath/barrier fencing below. Photographs in Section 9 (Figures 16 to 17).	vegetation and regeneration more frequent in the area with large grand fir where more light is reaching the ground, with ash (F) and other conifers such as western hemlock (O) regenerating. In the densest grand fir areas, ground vegetation is sparse and restricted to small pockets which need opening up.	fallen large deadwood. Archaeological features – an area of excavations into the slope have been recorded on the features map below (blue hatched area) – Initially some thought was given to whether these were charcoal burning platforms (as are quite often encountered on ancient woodland sites in this part of Wales), but this could not be confirmed.	are more Critical)	shaded conditions, which need opening up. Also where they are overtopping remnant broadleaves (particularly the mapped ash). Conifer and beech regeneration needs to be controlled, particularly where having an obvious impact on any nearby native regeneration.

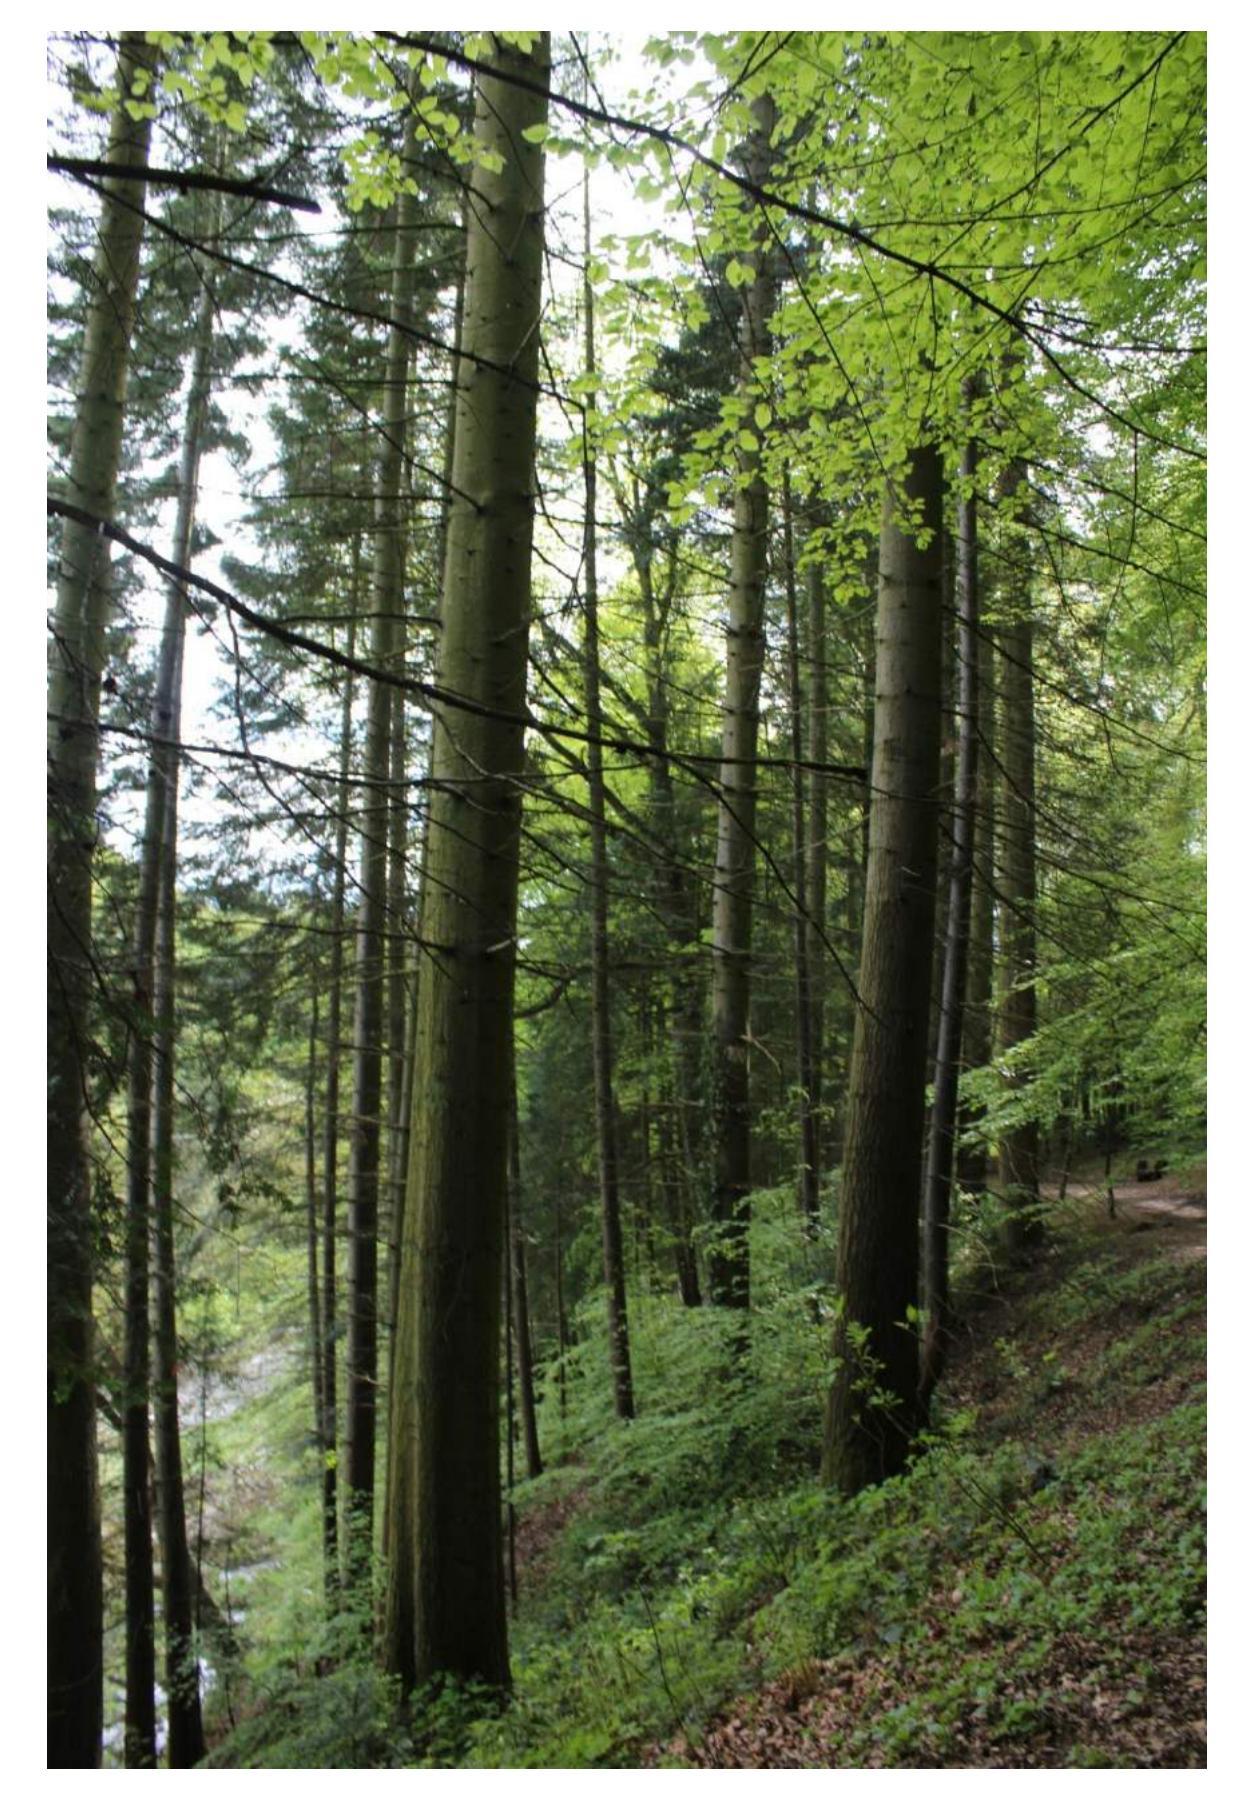
Figure 17 - Cmpt 2b - Large mature grand fir, with more ground cover beneath than in the denser conifer stands (May 2016)

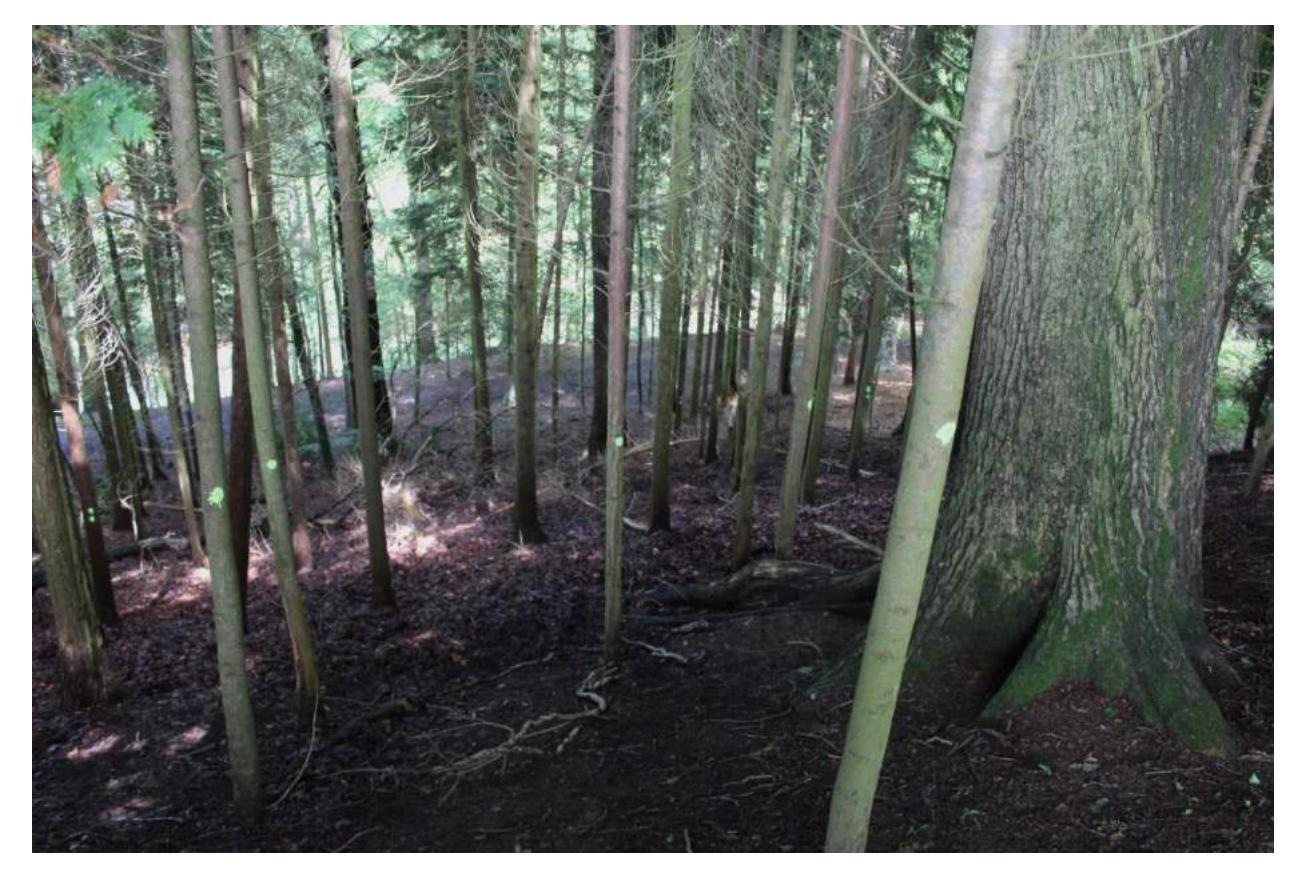
Figure 18 - Cmpt 3a - looking down into 3a - Western red cedar underplanted beneath large mature oaks. Supressed western red cedar of thin diameter and highly shading of ground, leaving no ground vegetation or natural regeneration (May 2016). Marked trees for thinning in August 2016. (Photo June 2016)

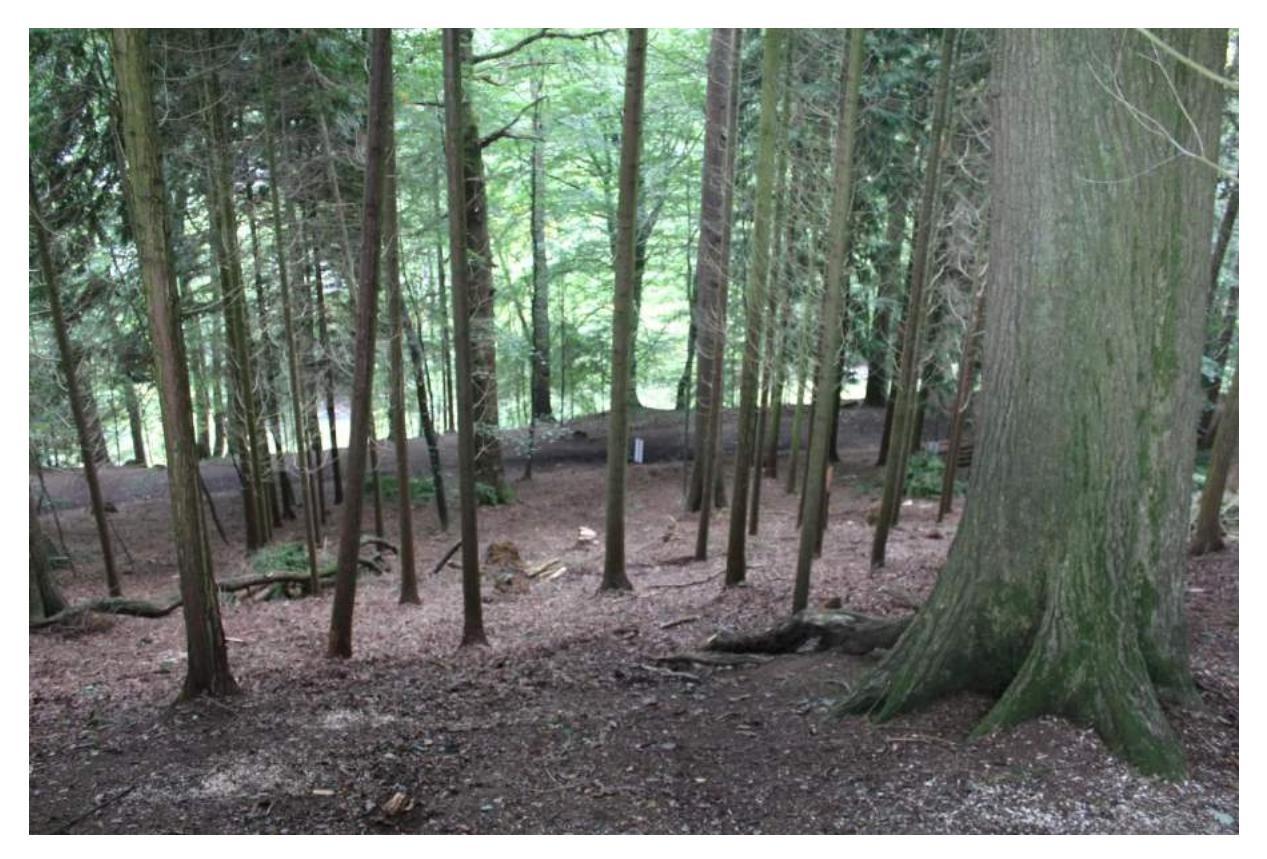
Figure 19 - Cmpt 3a – Same view after thinning (Photo August 2016)

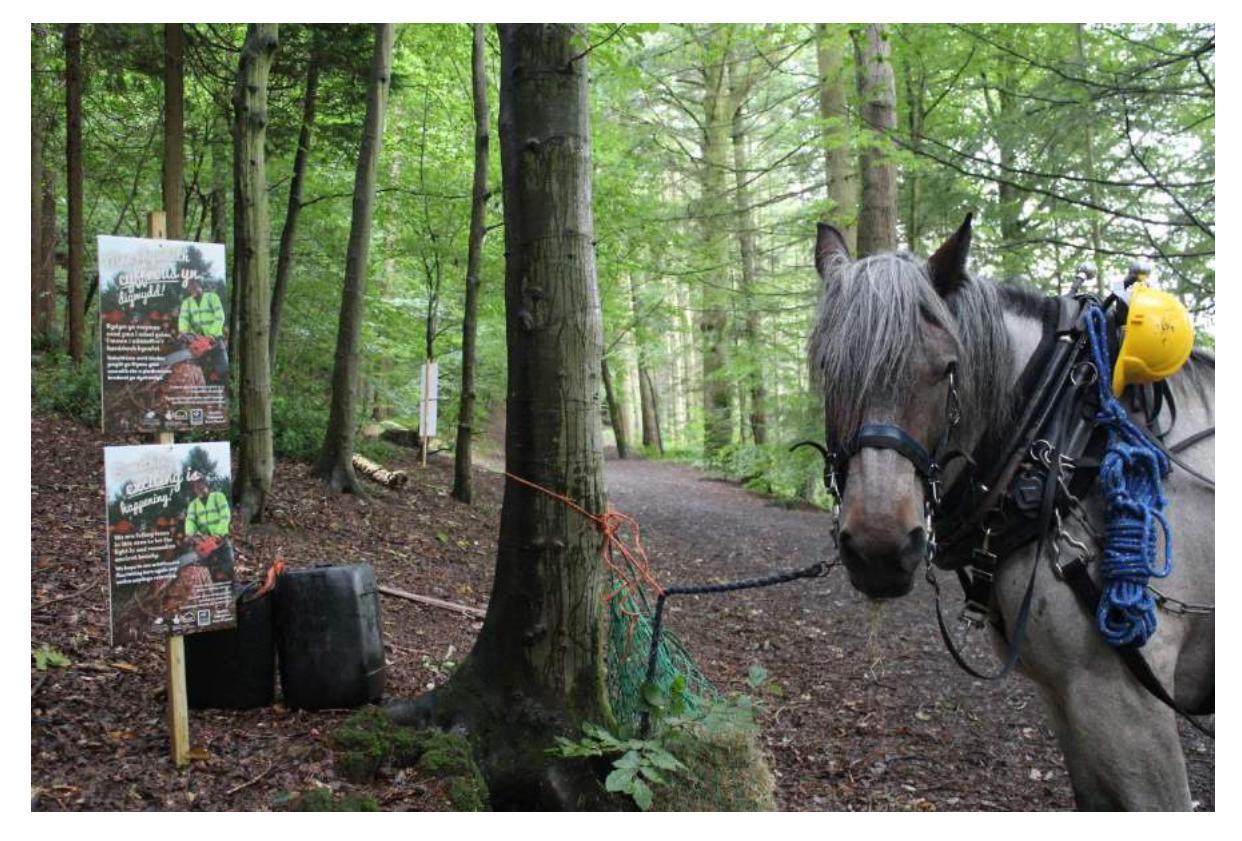
Figure 20 - <u>Cmpt 3a</u> - during the Wildlife Trust Bioblitz event, Woodland Trust funded horse-logging demonstration to extract the felled western red cedar to be stacked nearby. Interpretation signage produced by Woodland Trust to provide interpretation/information to passers-by (August 2016)

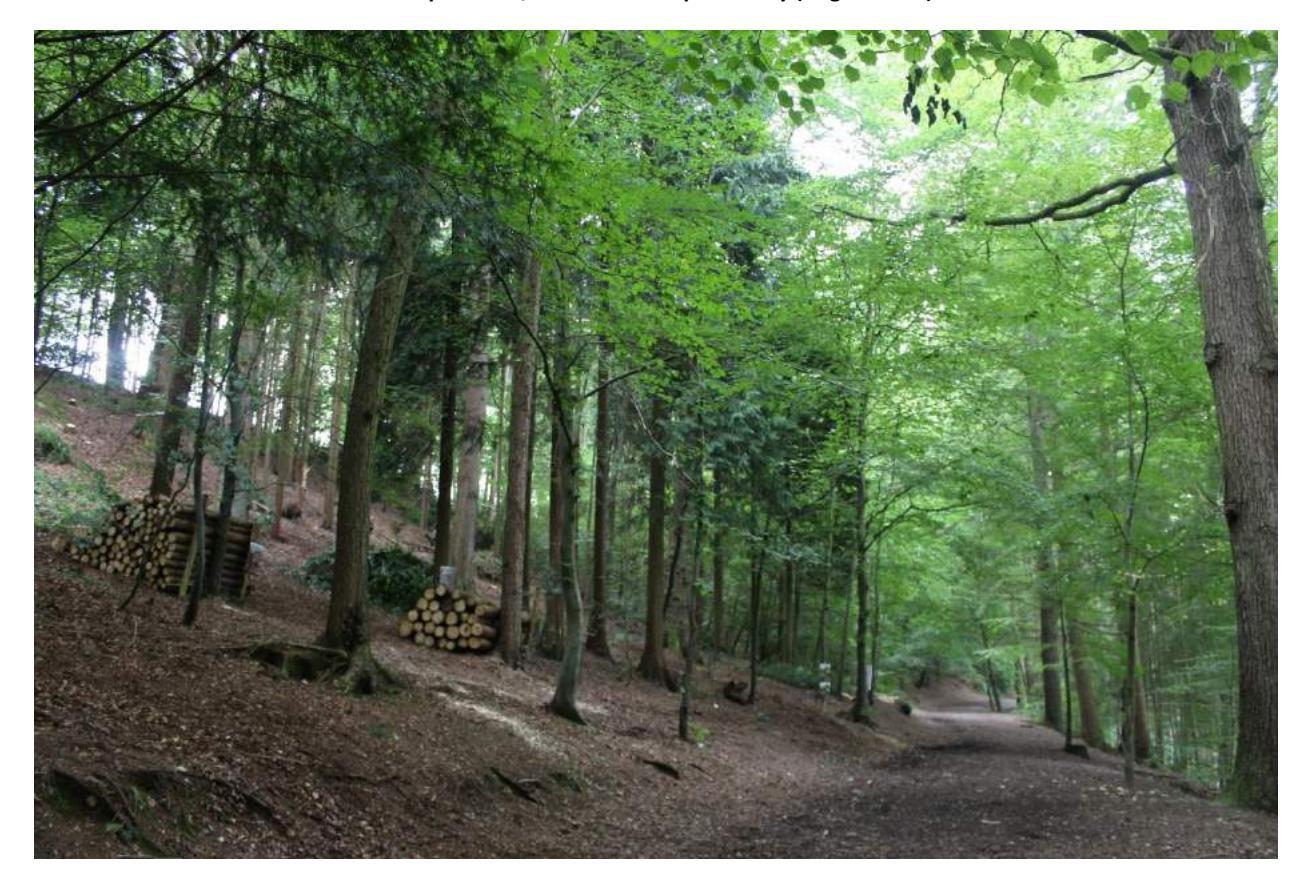
Figure 21 <u>- Cmpt 3a</u> (left) - looking down the main track, with stacked timber ready for use.

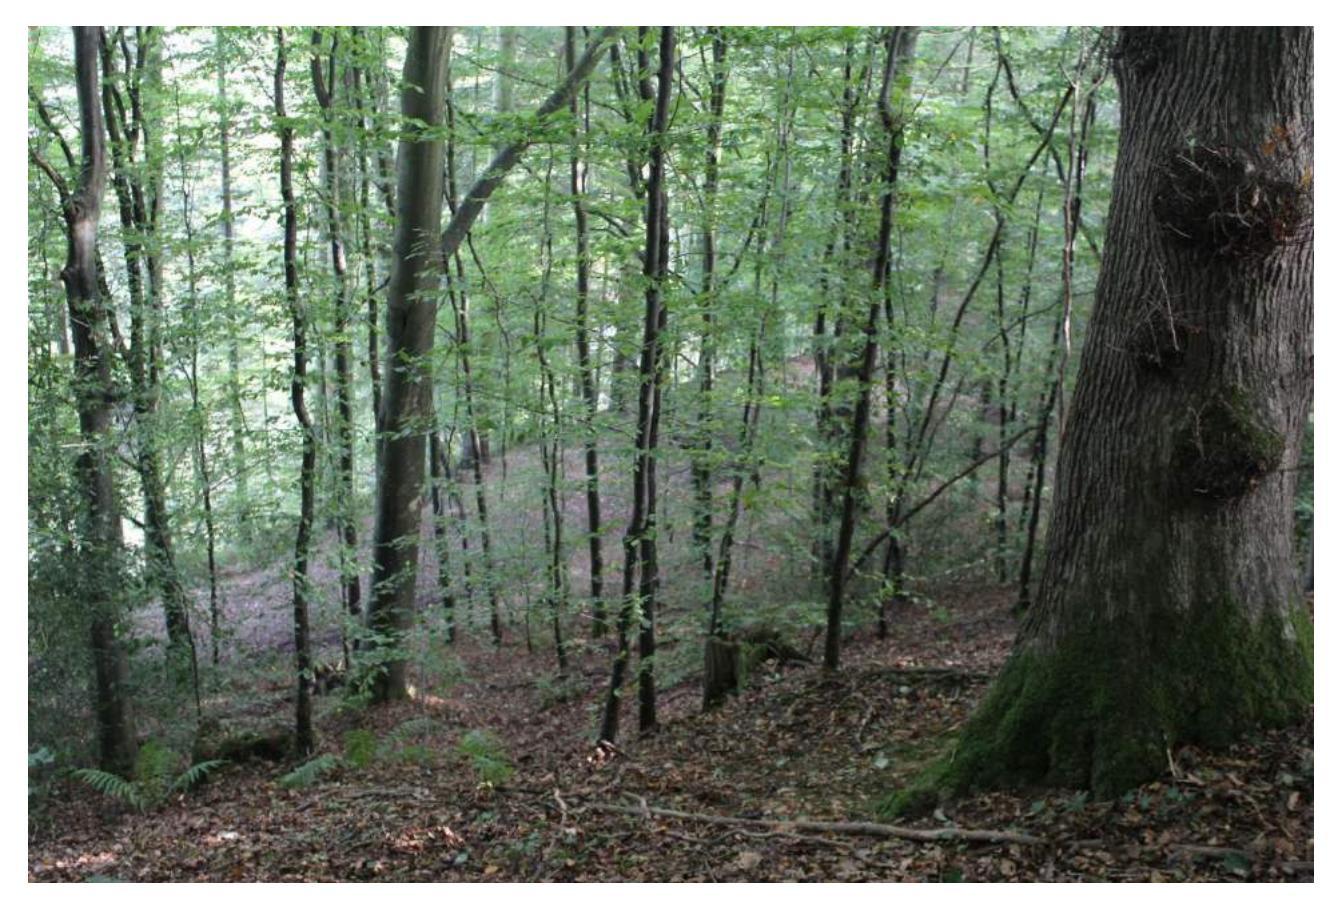
Figure 22 - Cmpt 4a - Typical view of the stand composition in this compartment, with large mature oaks, mature beech and abundant beech regeneration and underplanting (October 2016)

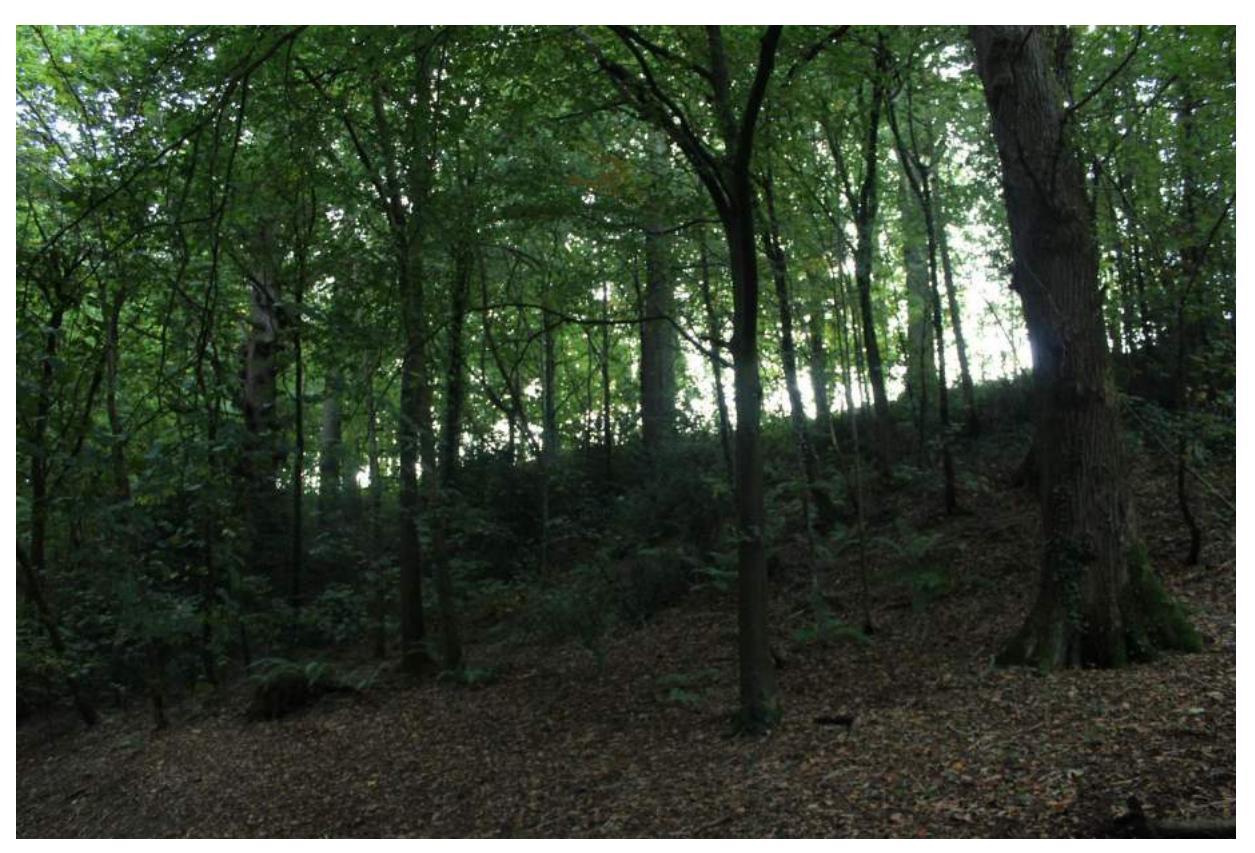
Figure 23 - Cmpt 4a – Mature oak with dense beech understory and occasional pockets of hazel, rowan, birch, cherry.

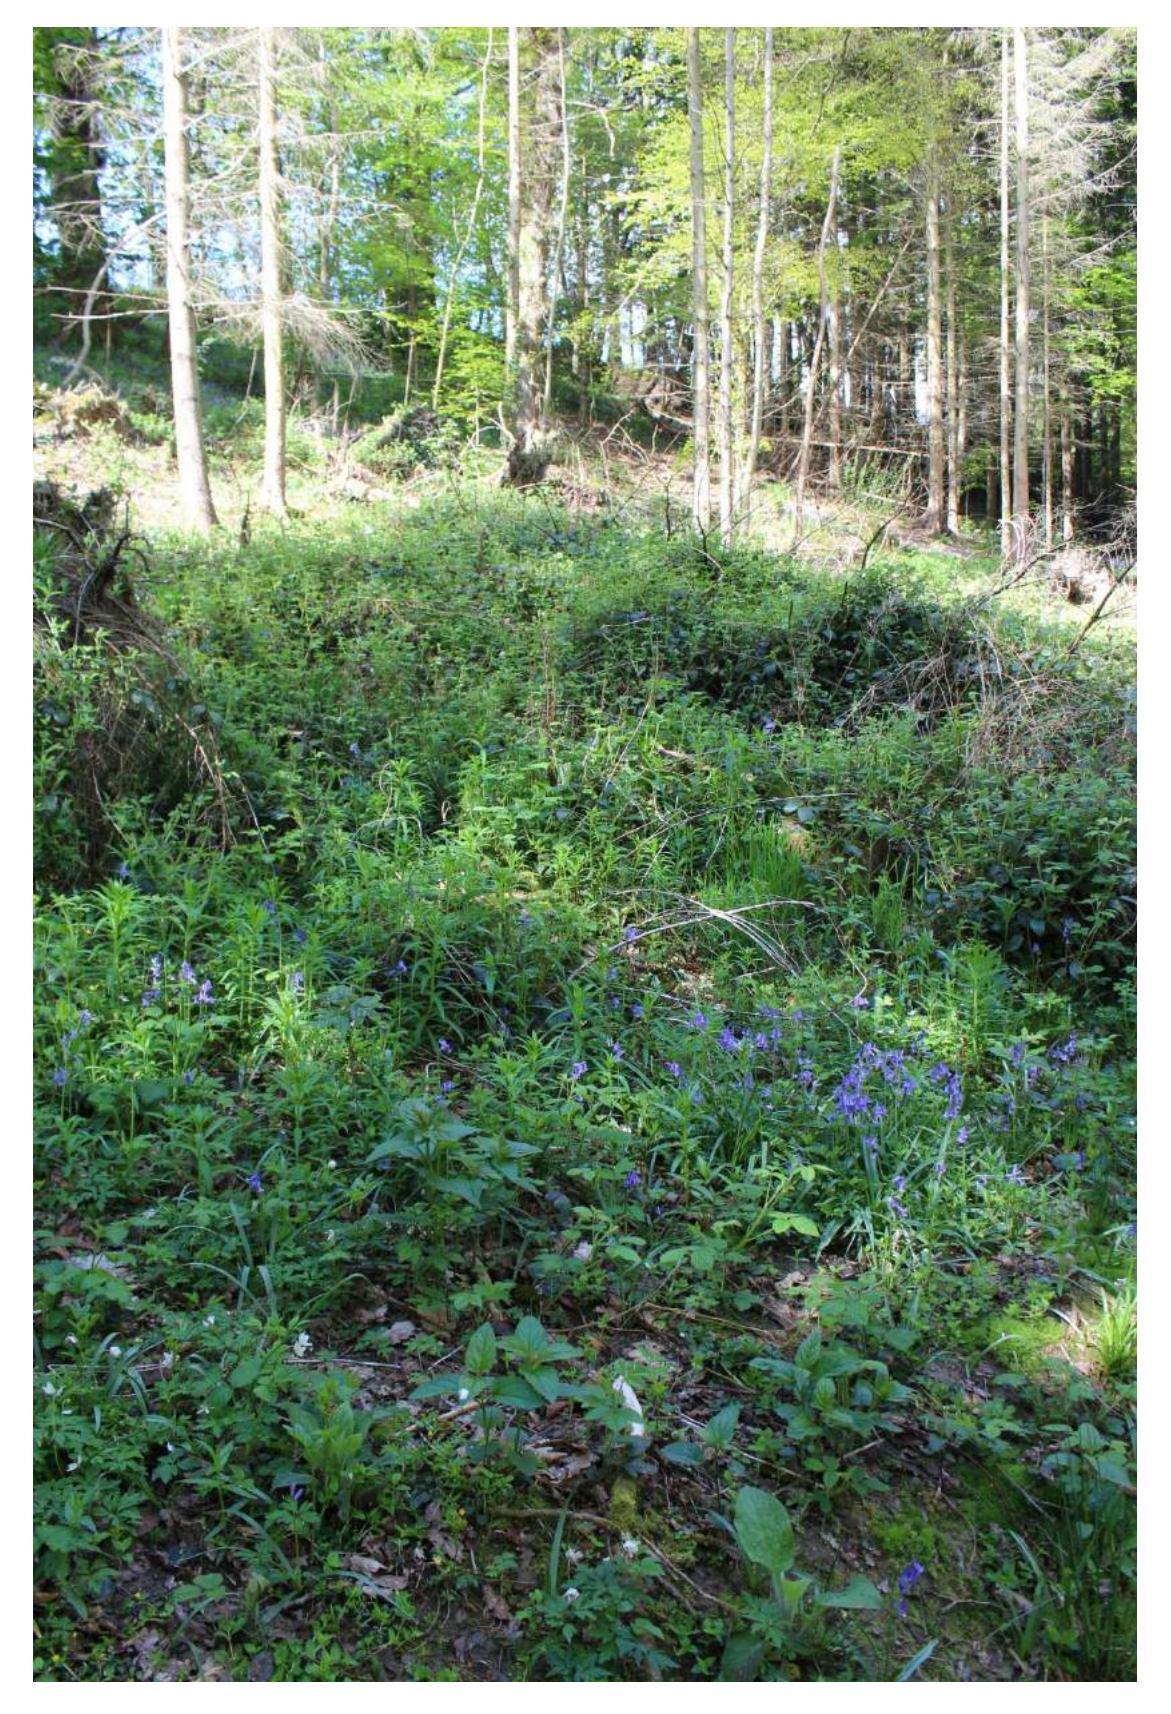
Figure 24 - <u>Cmpt 4b</u> – Small windblown area is a useful example of both the dormant ground vegetation (including ancient woodland plants such as bluebell, wood anemone, yellow pimpernel, and great wood rush here) but also the potential issues with opening up the stand too quickly and the subsequent growth of coarse vegetation including bramble and willowherb which later in the year are a lot more dominant (May 2016)

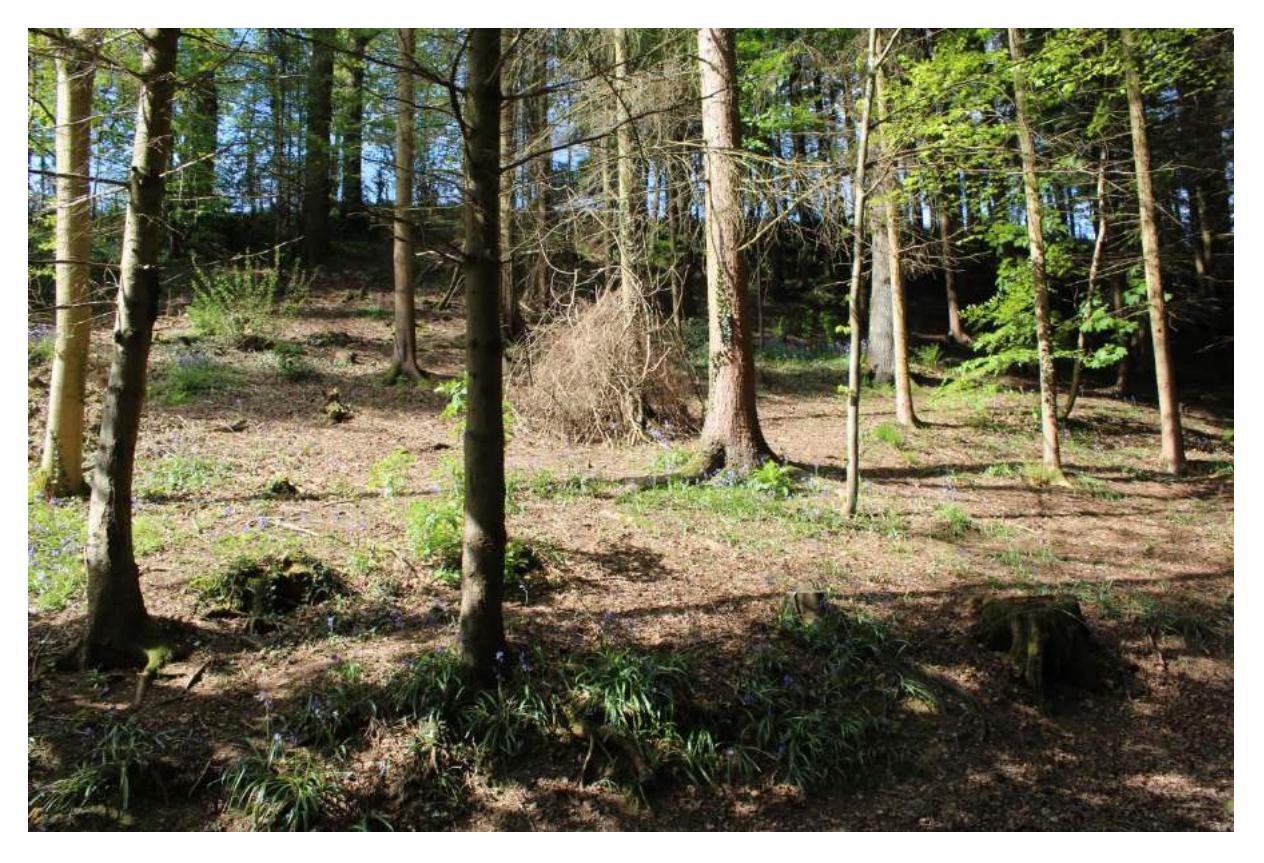
Figure 25 - <u>Cmpt 5a</u> – on the right of the photo, with the edge of Cmpt 4b on the left, showing the bluebells and ground vegetation in the sunlight, with the heavy shade further into the stand. (May 2016)

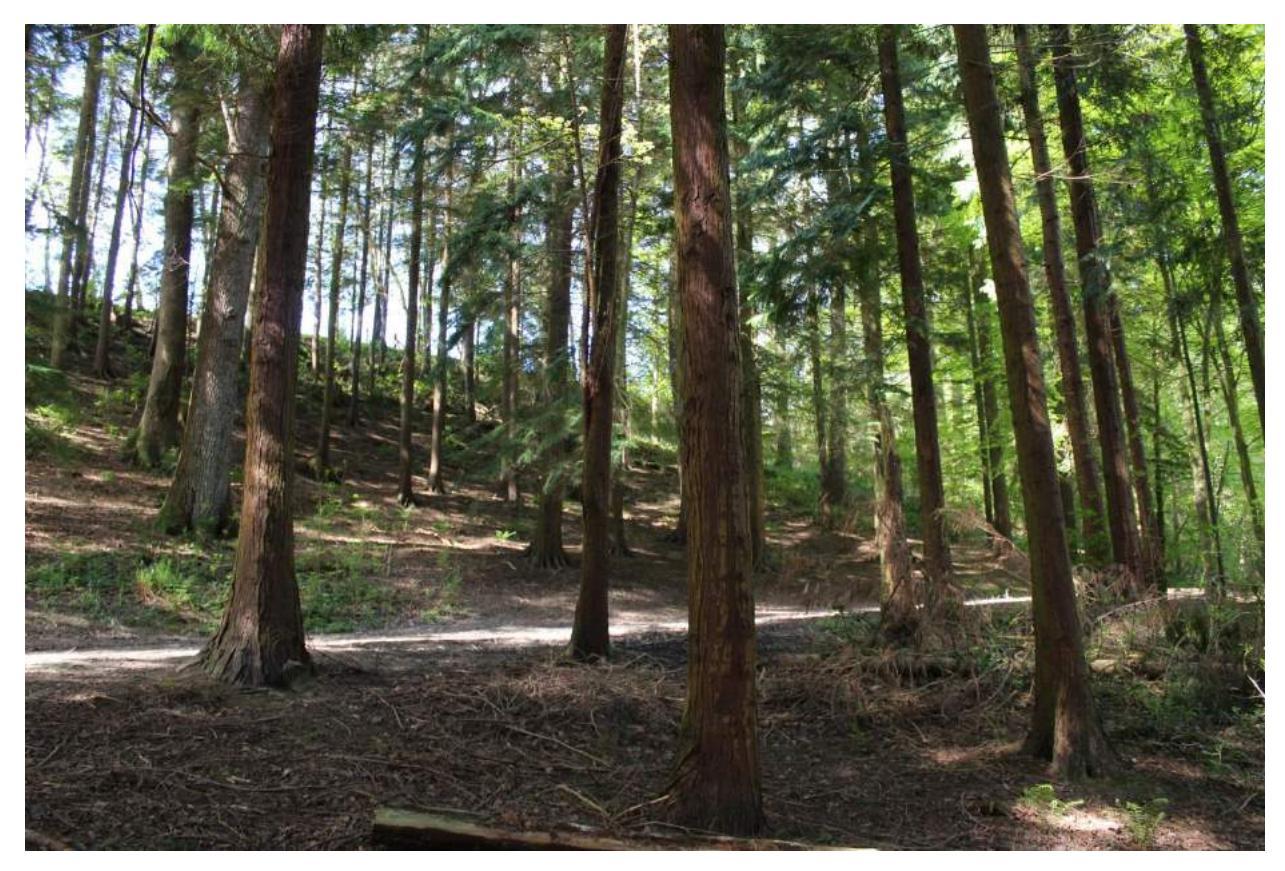
Figure 26 - <u>Cmpt 5a</u> (on the other side of the track, 5b in the foreground) – Showing the mature hemlock with occasional large mature oak and pockets of ground vegetation/regeneration where light is reaching the ground – needing opening up (May 2016)

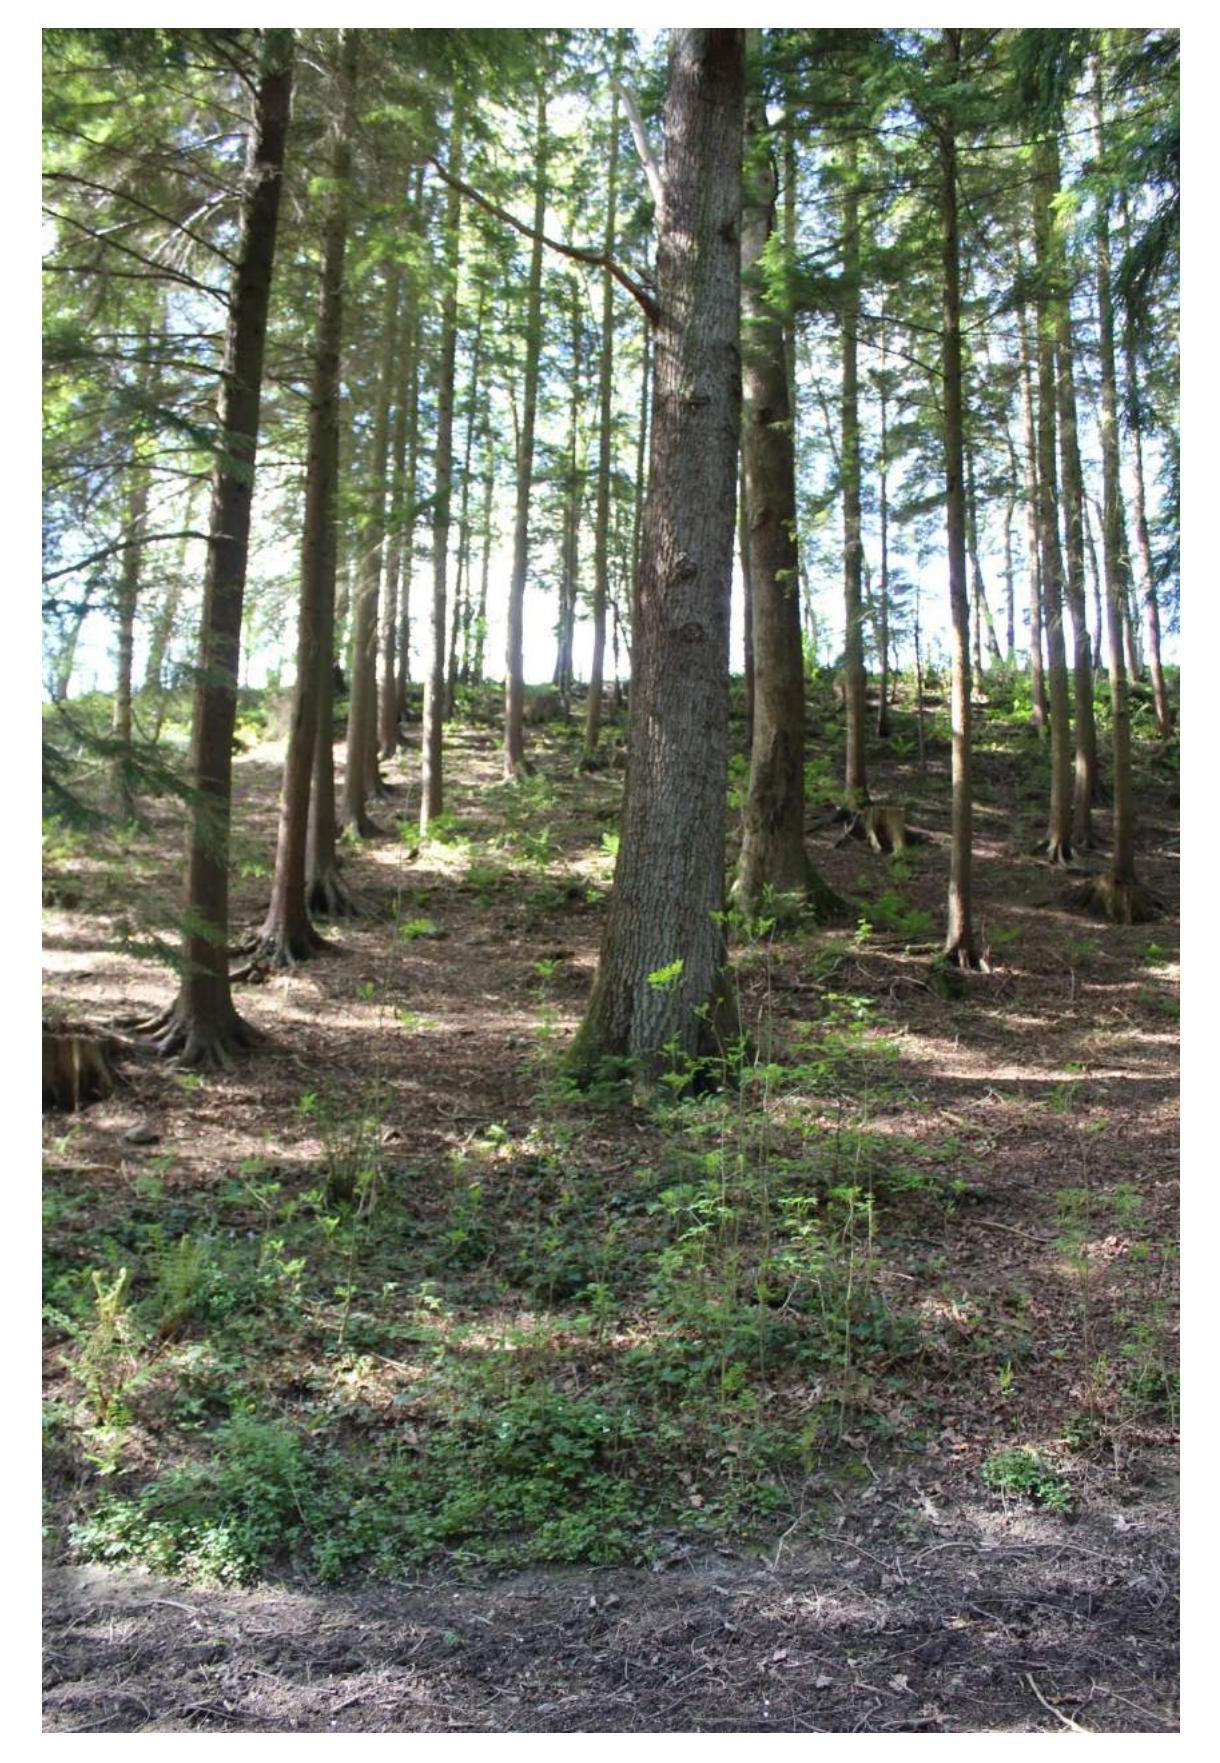
Figure 27 - Cmpt 5a - Mature pre-plantation oaks surrounded with western hemlock and western red cedar. A small trackside pocket of ash regeneration and ground vegetation (with bluebells, scaly male fern, wood speedwell etc.) can be seen in the foreground – an example of the sort of feature which needs 'releasing' through opening up the conifer canopy. (October 2016)

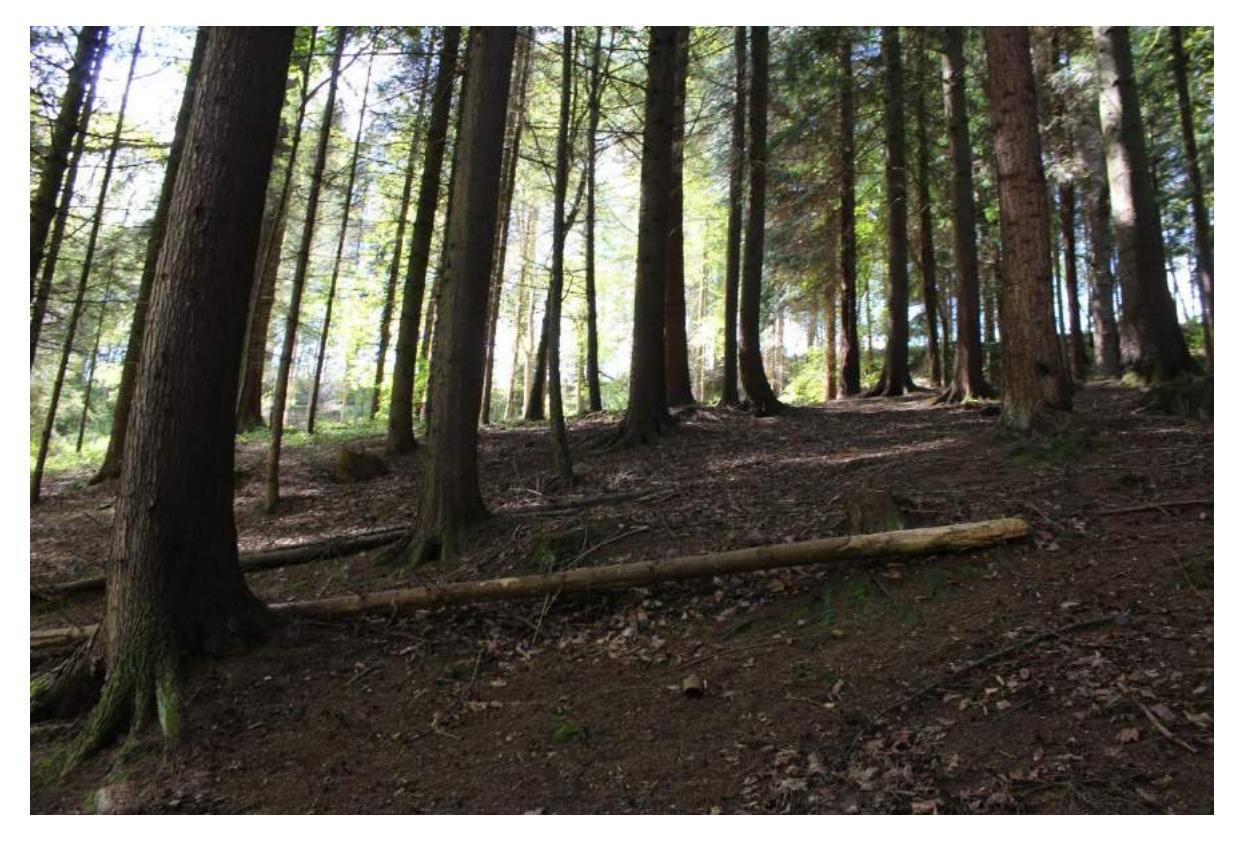
Figure 28 - <u>Cmpt 5b</u> – The lower part of the 5b, with dense, heavily shading, Western hemlock with no ground vegetation or regeneration. (May 2016)

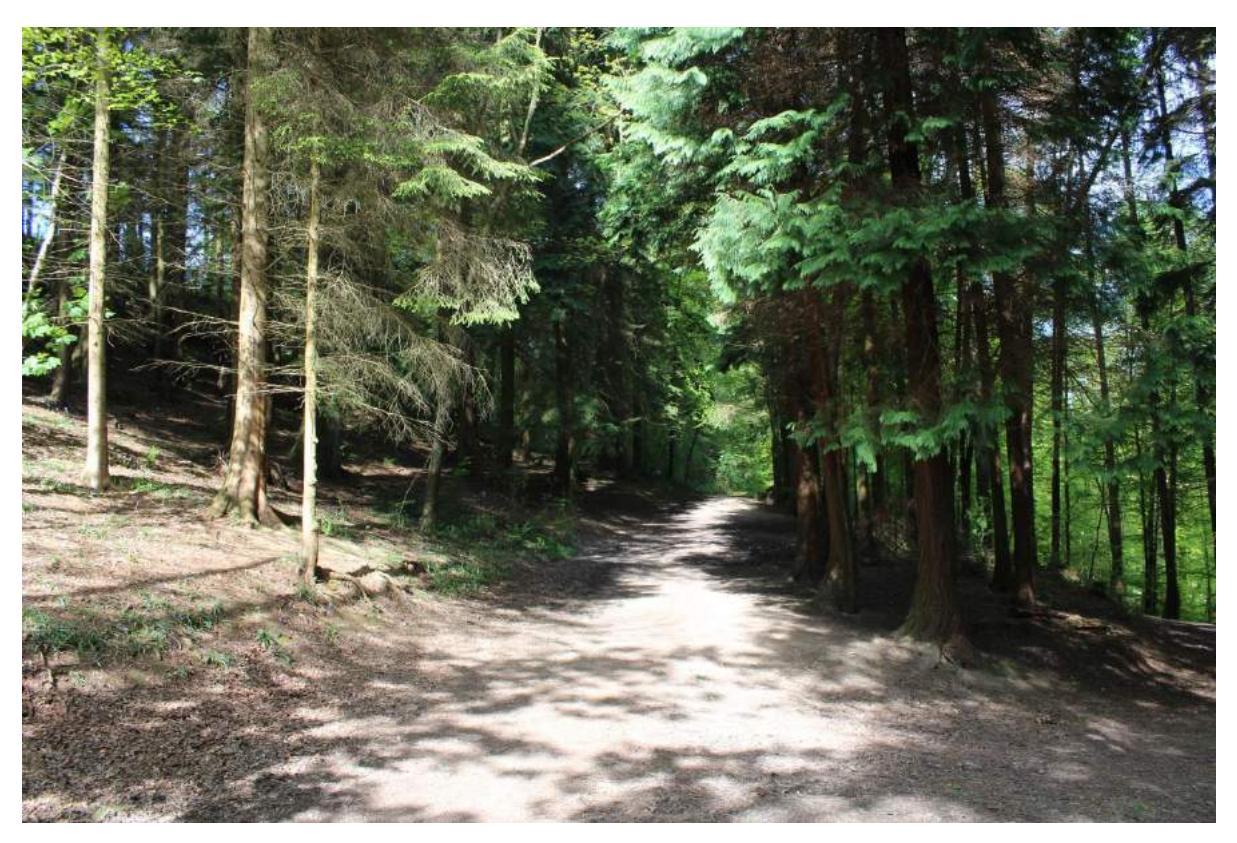
Figure 29 - Cmpt 5b (right) and 5a (left), with the main central track. (May 2016)

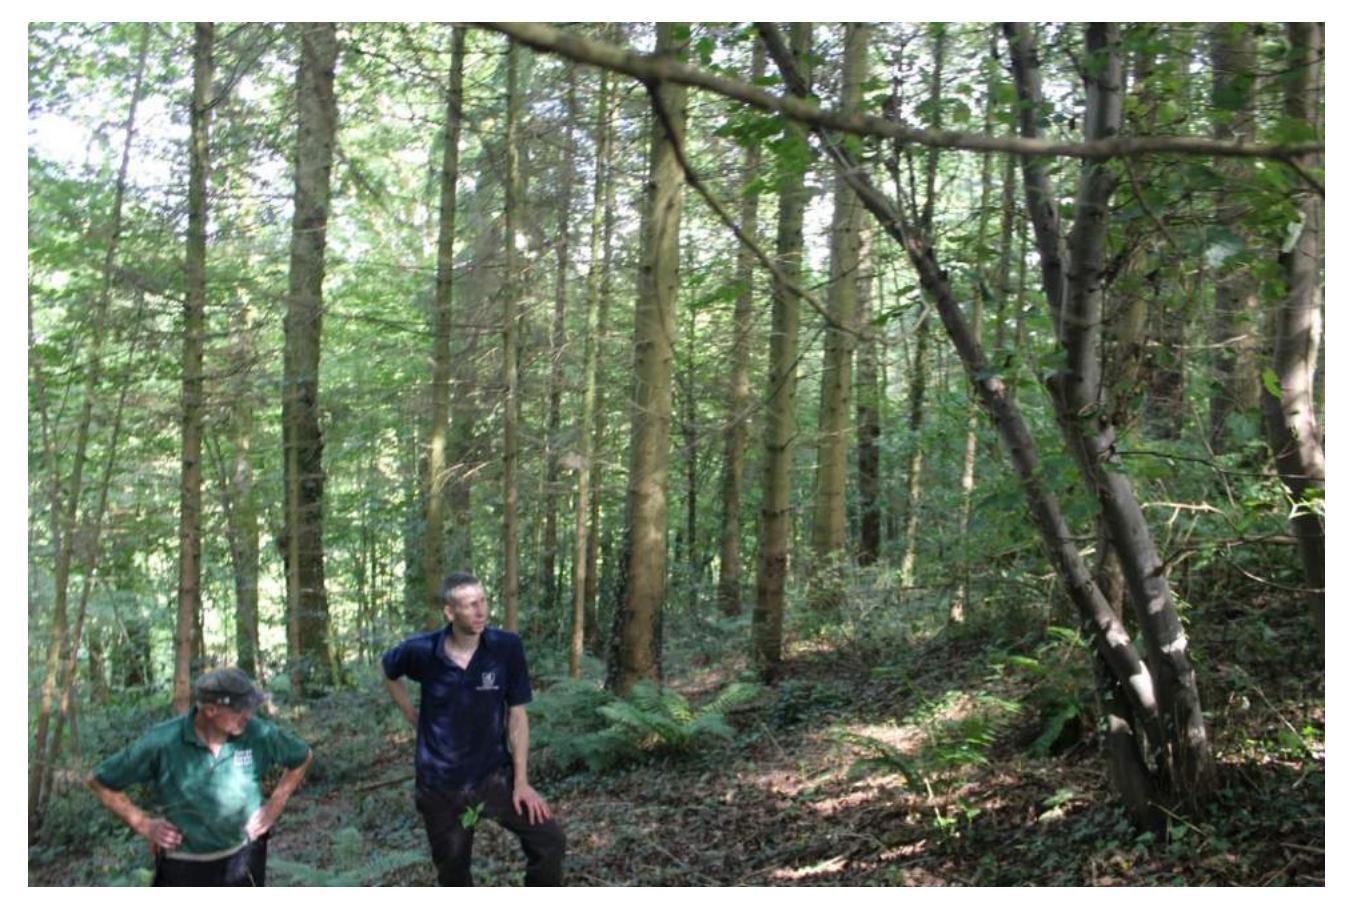
Figure 30 - <u>Cmpt 6a</u> - a distinctive stand of Norway Spruce with mature oak and also mature cherry, some ash above. Also reasonable ground vegetation cover, including locally frequent bluebells in spring.
