Ancient Woodland Restoration

Deri Wood / Coed y Deri

Woodland Name: Deri Wood / Coed y Deri Location: Llanfair Caereinion, Powys Grid ref: SJ097066 Total Woodland Area: 5.35ha Area PAWS: 4.14ha (On Inventory as RAWS) Area ASNW: None (Riverside section of Goat Field could be considered ASNW) Area RAWS: None Area AWI Unknown: None Designations: None Ownership: Llanfair Caereinion Town Council Managed By: Montgomeryshire Wildlife Trust & Llanfair Caereinion Town Council Field Survey: 16th May 2016, 17th June 2016, 18th August 2016 & 10th October 2016 Report Date: 20th October 2016 Report Author: Alastair Hotchkiss (Ancient Woodland Restoration Officer, Woodland Trust)

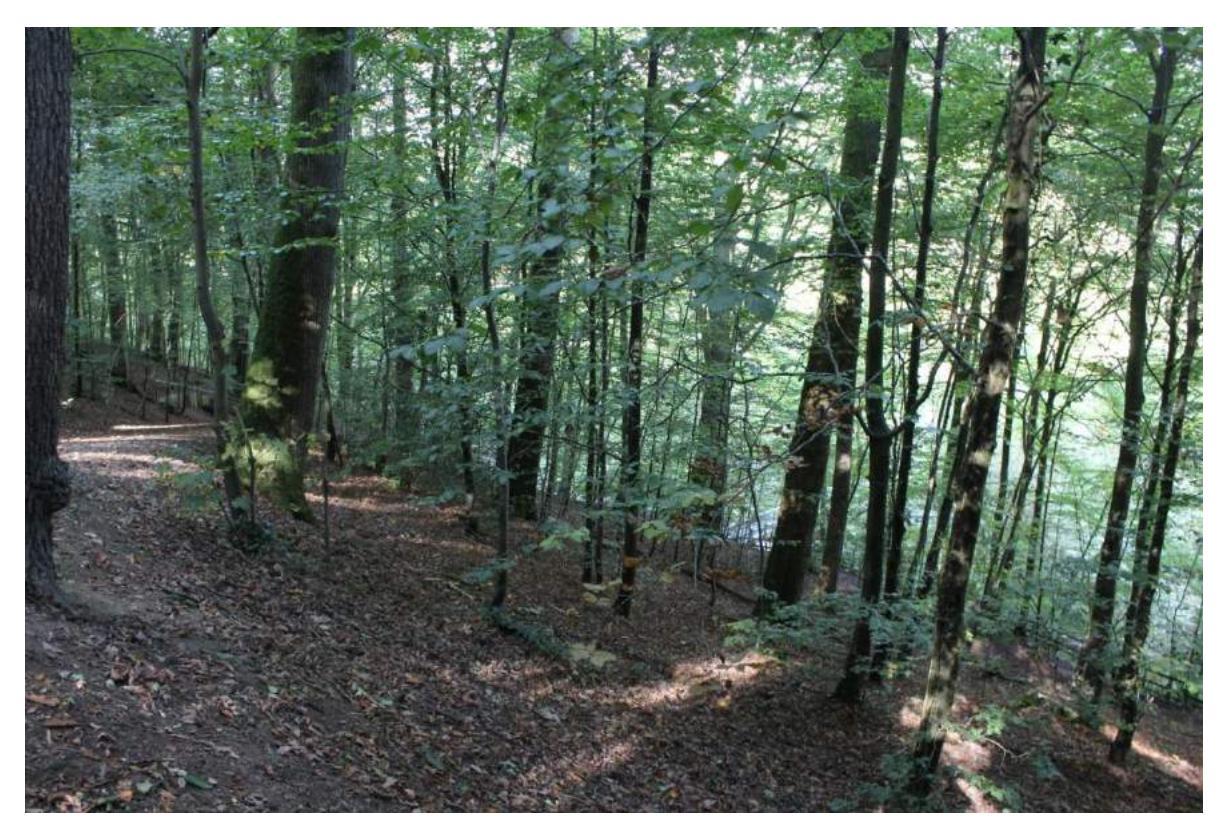
Figure 31 - Cmpt 7a - Some of the densest beech on the site with bare ground beneath. (October 2016)

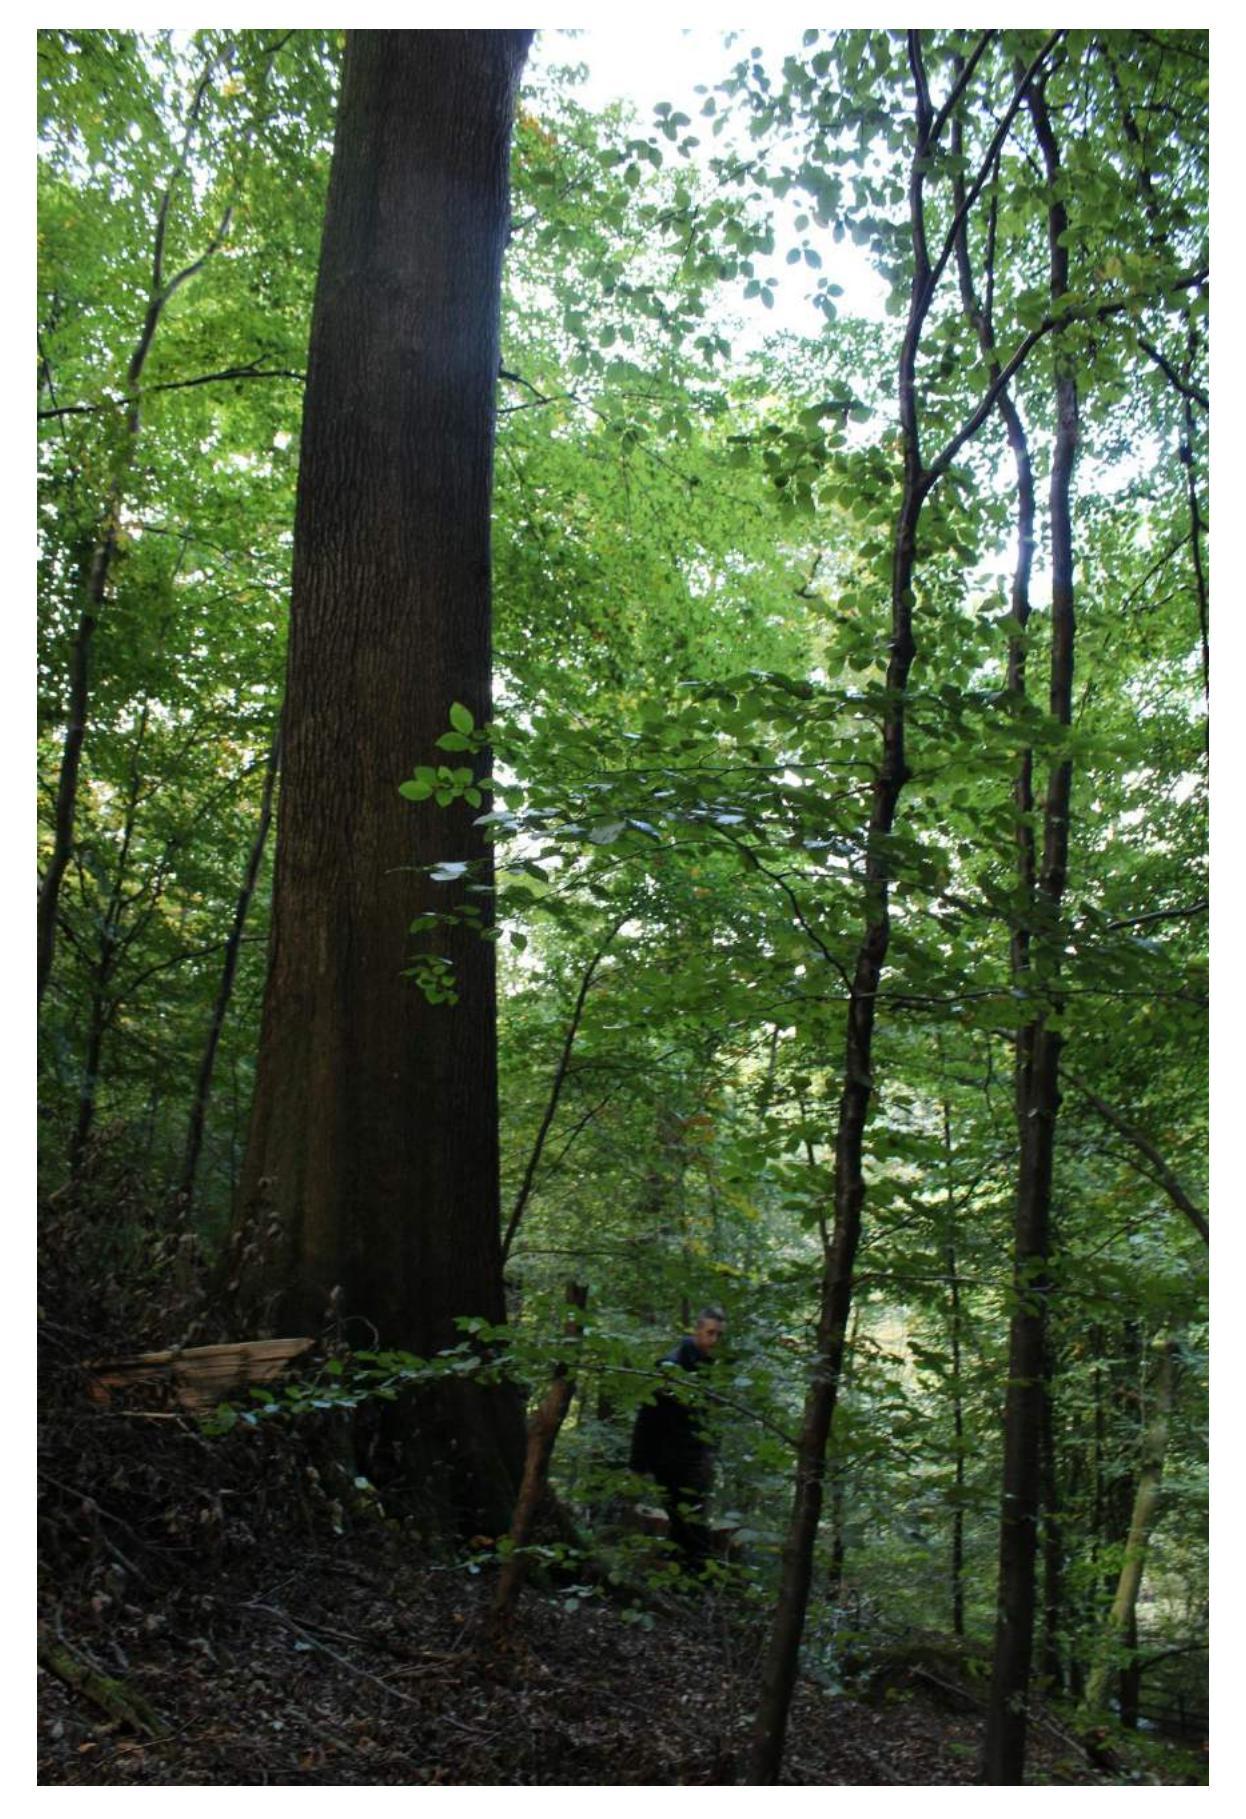
Figure 32 - <u>Cmpt 7a</u> - An example of one of the largest oaks on the site (135cm DBH).

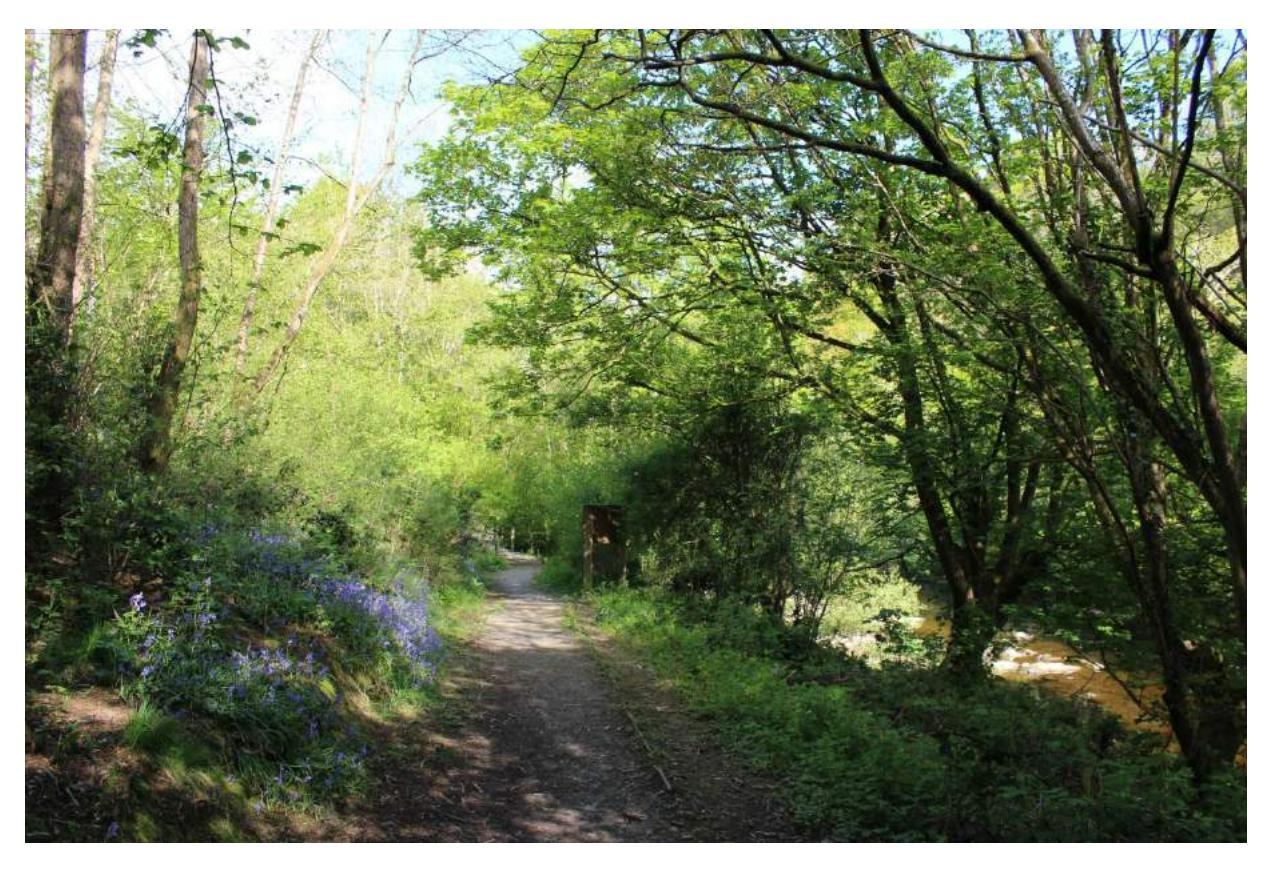
Figure 33 - Cmpt 8a - Riverside woodland in Goat Field with rich ground vegetation.

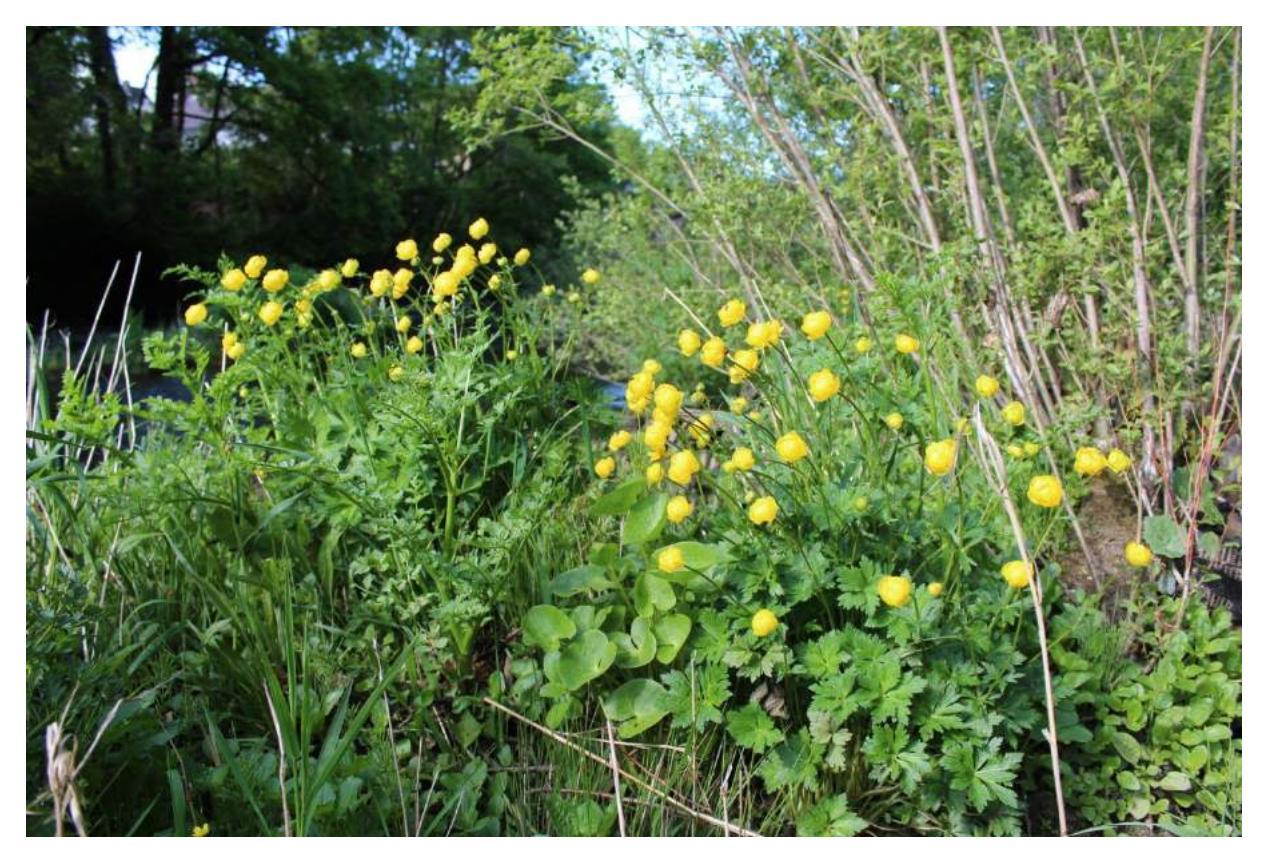
Figure 34 - Globeflower on the Afon Banwy (May 2015). Photo taken from the rocks in the river Banwy further downstream toward Llanfair, but this uncommon and notable species also occurs on the river rocks at Deri Wood.
